ASBESTOS CONTRACTING LIMITED

Asbestos Re-Inspection for West Moors Memorial Hall

West Moors Memorial Hall
231 Station Road
West Moors
Dorset
BH22 0HZ

Project Number: AS10008 & AS10120

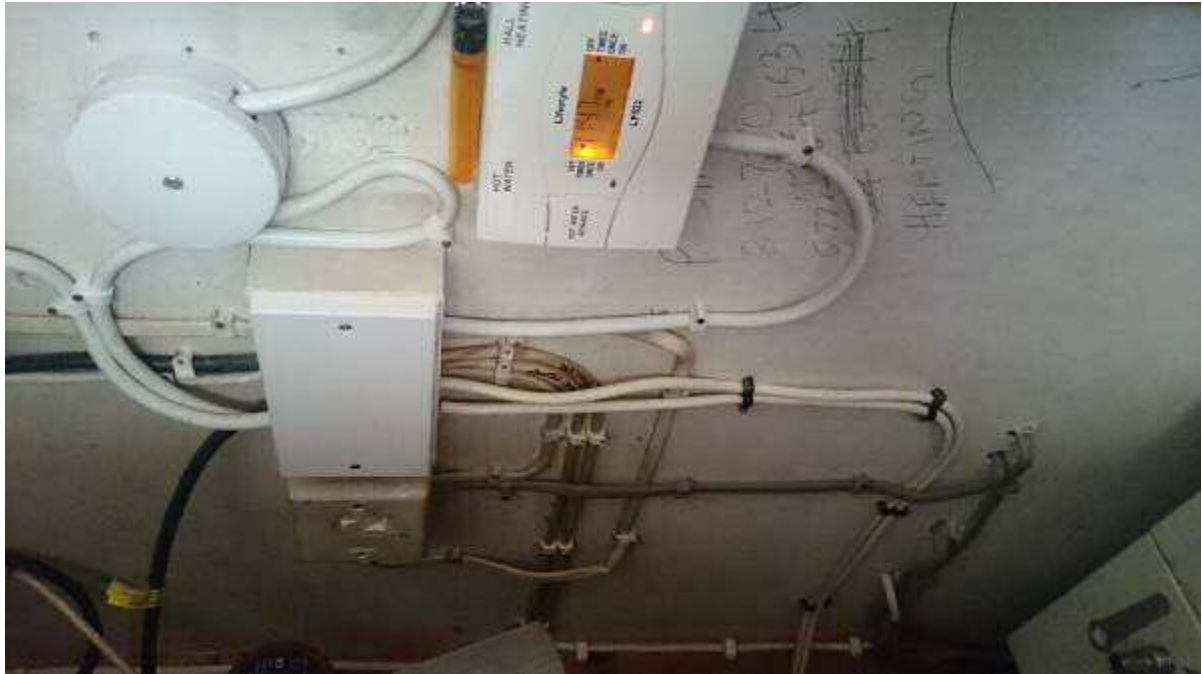
Location ID:	18388	Survey Type:	MS
Location Ref:	Sample 1	Product Type:	NADIS
Product:	Insulation Board	Damage:	NADIS
Area:	01	Treatment:	NADIS
Floor:	Ground floor	Asbestos Type:	NADIS
Room:	Kitchen	Identification:	Identified
Surveyor Name:	[REDACTED]	Quantity:	3m ²
Drawing Ref:	01		
Asbestos ?	No		
Date:	29 March 2016		
Next Inspection:	Not Applicable

Material Comments: Insulation board panel forming wall to boiler cupboard.

Action: No Action Required

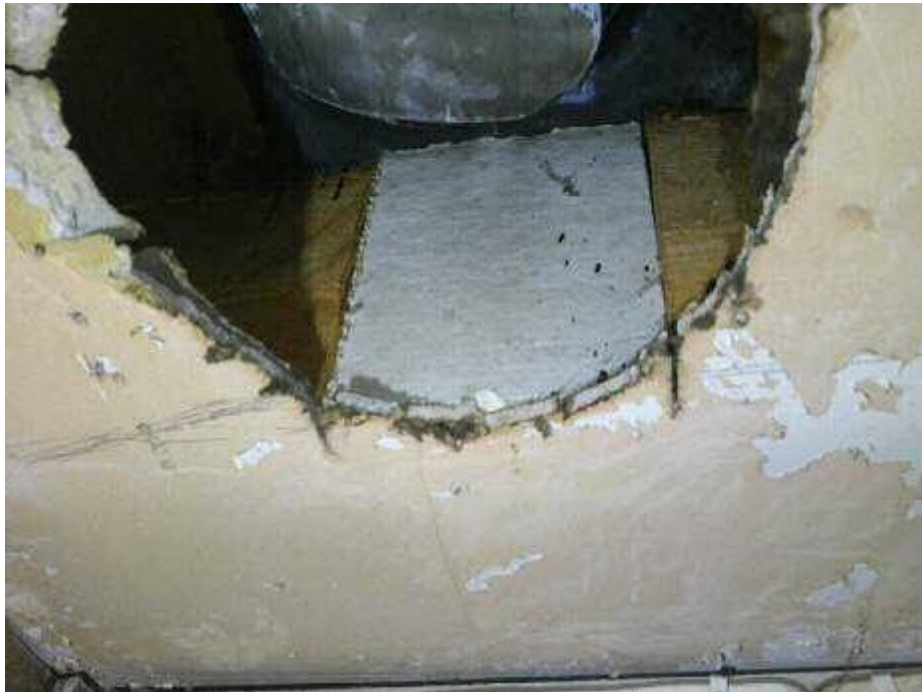
Location ID:	18391	Survey Type:	RI
Location Ref:	Visual ID	Product Type:	NADIS
Product:	Insulation Board	Damage:	NADIS
Area:	01	Treatment:	NADIS
Floor:	Ground floor	Asbestos Type:	NADIS
Room:	Kitchen	Identification:	Identified
Surveyor Name:	[REDACTED]	Quantity:	Small
Drawing Ref:	01		
Asbestos ?	No		
Date:	05 January 2023		
Next Inspection:	Not Applicable		
		Material Risk Score:	0
		Material Risk Band:	NADIS
		Priority Risk Score:	N/A

Material Comments: Panel above ceiling next to flue in boiler cupboard. Identified as supalux (same as wall panel below) on 2023 re-inspection.

Action: **No Action Required**

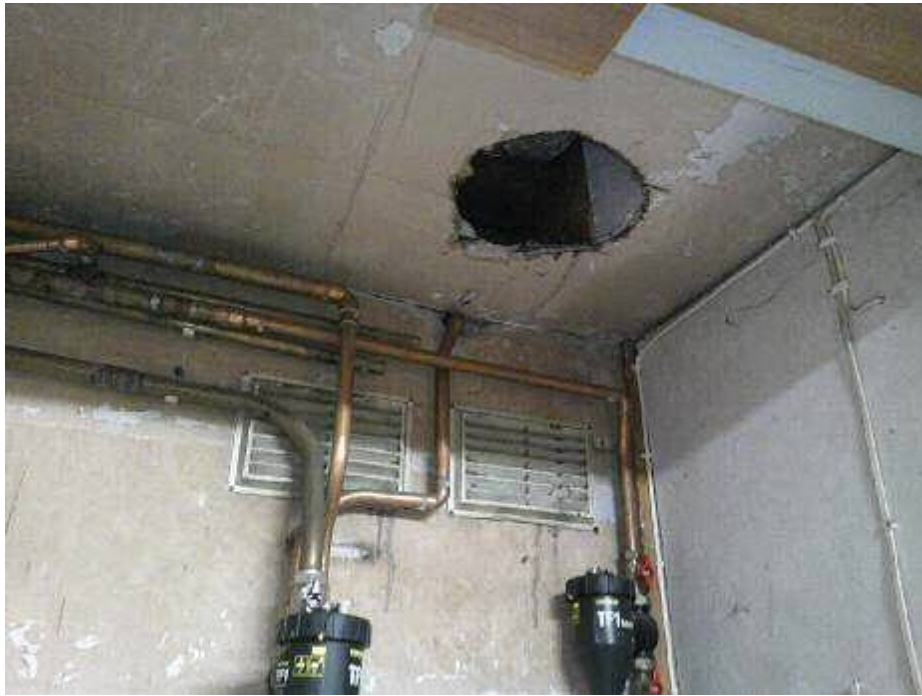
Location ID:	18385	Survey Type:	RI
Location Ref:	Visual ID	Product Type:	NADIS
Product:	Cement flue pipe	Damage:	NADIS
Area:	01	Treatment:	NADIS
Floor:	Ground floor	Asbestos Type:	NADIS
Room:	Kitchen	Identification:	Identified
Surveyor Name:	[REDACTED]	Quantity:	1 Linear Metre
Drawing Ref:	01		
Asbestos ?	No		
Date:	05 January 2023		
Next Inspection:	Not Applicable

Material Comments: Asbestos cement flue pipe in boiler cupboard. Found to have been removed on 2023 re-inspection.

Action: No Action Required

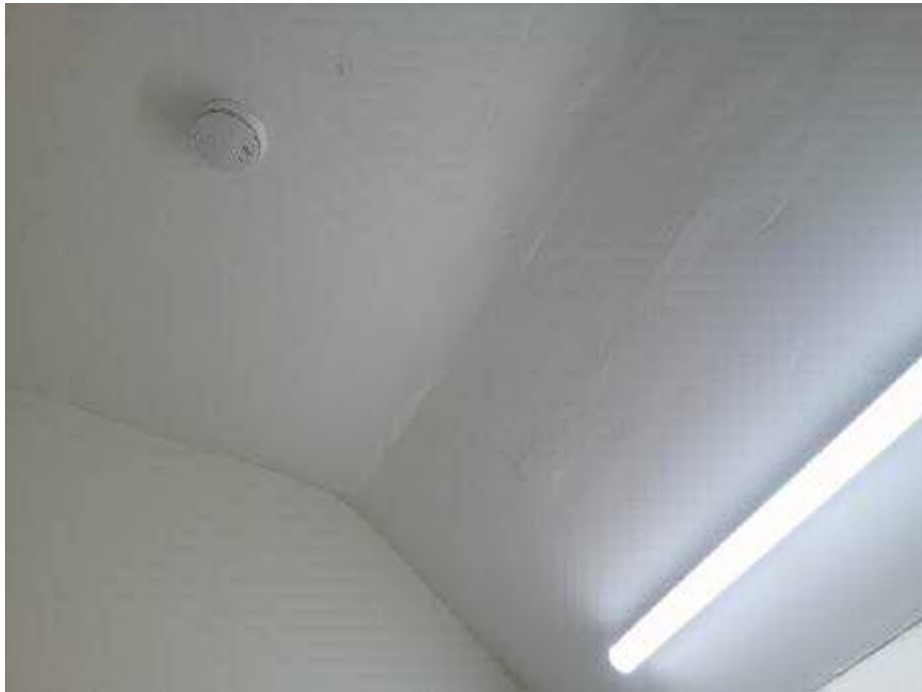
Location ID:	18394	Survey Type:	RI
Location Ref:	Visual ID to sample 2	Product Type:	Asbestos cement
Product:	Cement board	Damage:	Good condition
Area:	03	Treatment:	Asbestos cement sheets etc
Floor:	Ground floor	Asbestos Type:	Chrysotile
Room:	Lobby	Identification:	Strongly Presumed as previous sample
Surveyor Name:	[REDACTED]	Quantity:	6m ²
Drawing Ref:	03		
Asbestos ?	Yes		
Date:	05 January 2023		
Next Inspection:	05 January 2024

Material Risk Score:	3
Material Risk Band:	Very Low Risk
Priority Risk Score:	4

Material Comments: Ceiling panels. Plasterboard ceiling in place on 2023 re-inspection, based on evidence in the loft space strongly presumed still present above.

Action: **Apply Warning Labels & Annually Re-Inspect**

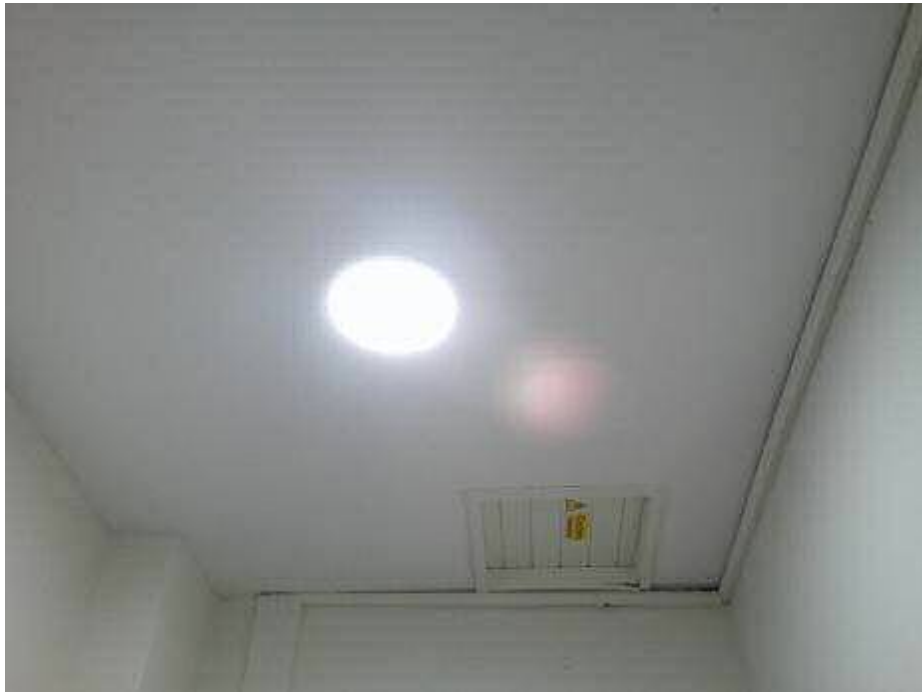
Location ID:	18400	Survey Type:	RI
Location Ref:	Visual ID to sample 2	Product Type:	Asbestos cement
Product:	Cement board	Damage:	Good condition
Area:	04	Treatment:	Asbestos cement sheets etc
Floor:	Ground floor	Asbestos Type:	Chrysotile
Room:	Lobby	Identification:	Strongly Presumed as previous sample
Surveyor Name:	[REDACTED]	Quantity:	8m ²
Drawing Ref:	04		
Asbestos ?	Yes		
Date:	05 January 2023		
Next Inspection:	05 January 2024		
		Material Risk Score:	3
		Material Risk Band:	Very Low Risk
		Priority Risk Score:	4

Material Comments: Ceiling panels. Plasterboard ceiling in place on 2023 re-inspection, based on evidence in the loft space strongly presumed still present above.

Action: Apply Warning Labels & Annually Re-Inspect

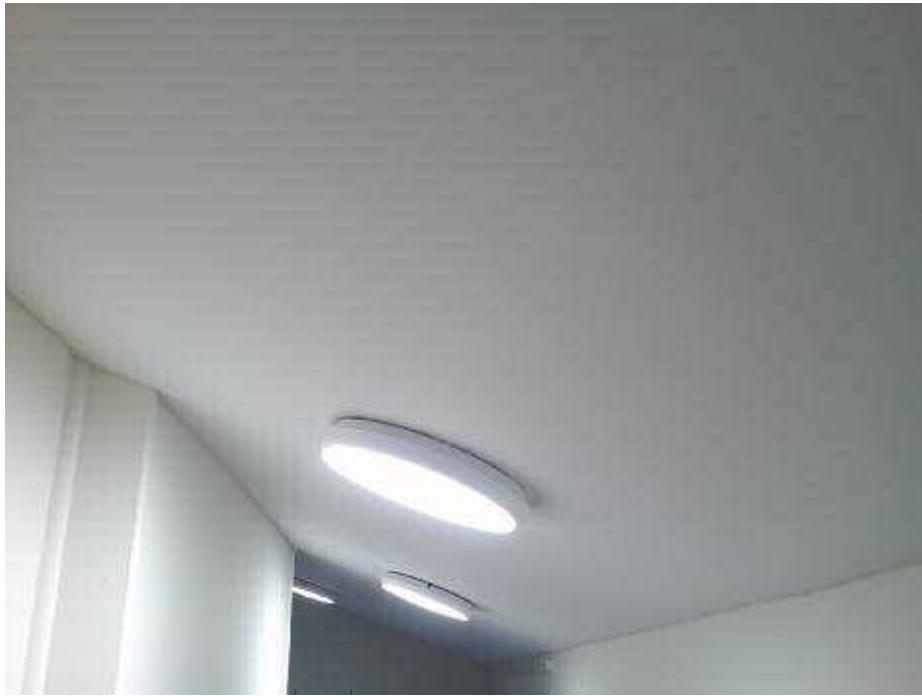
Location ID:	18402	Survey Type:	RI
Location Ref:	Sample 2	Product Type:	Asbestos cement
Product:	Cement board	Damage:	Good condition
Area:	05	Treatment:	Asbestos cement sheets etc
Floor:	Ground floor	Asbestos Type:	Chrysotile
Room:	Circulation	Identification:	Identified
Surveyor Name:	[REDACTED]	Quantity:	8m ²
Drawing Ref:	05		
Asbestos ?	Yes		
Date:	05 January 2023		
Next Inspection:	05 January 2024

Material Risk Score:	3
Material Risk Band:	Very Low Risk
Priority Risk Score:	4

Material Comments: Ceiling panels. Plasterboard ceiling in place on 2023 re-inspection, based on evidence in the loft space strongly presumed still present above.

Action: **Apply Warning Labels & Annually Re-Inspect**

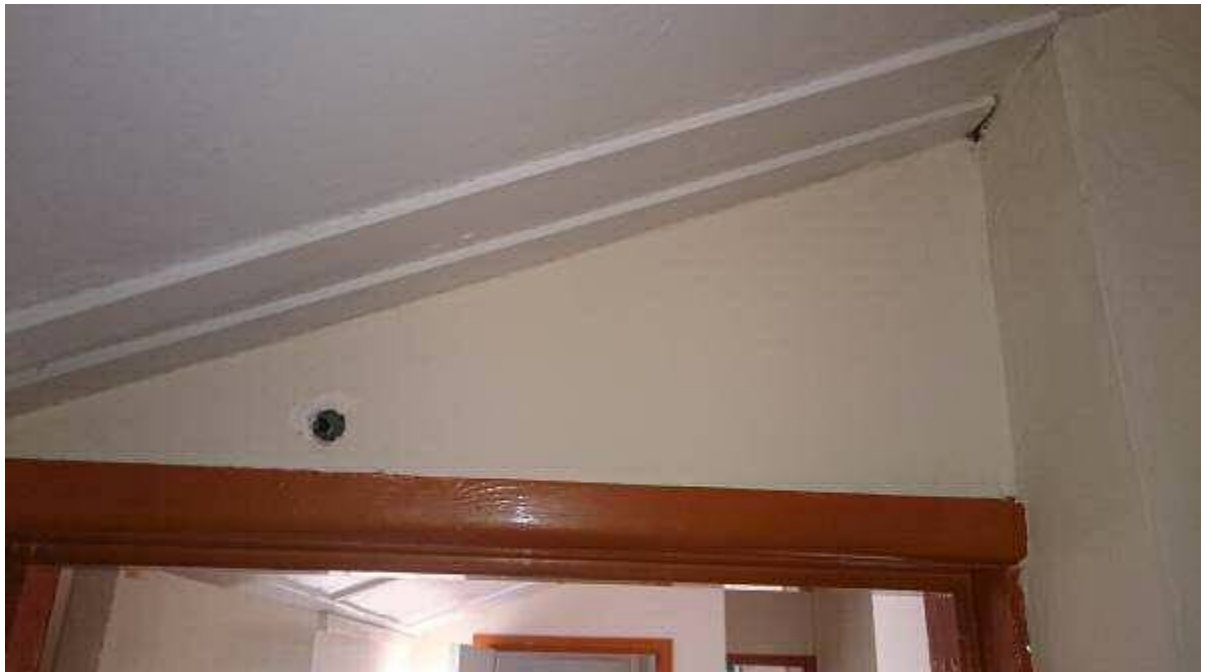
Location ID:	18405	Survey Type:	MS
Location Ref:	Sample 3	Product Type:	NADIS
Product:	Insulation Board	Damage:	NADIS
Area:	05	Treatment:	NADIS
Floor:	Ground floor	Asbestos Type:	NADIS
Room:	Circulation	Identification:	Identified
Surveyor Name:	[REDACTED]	Quantity:	1m ²
Drawing Ref:	05		
Asbestos ?	No		
Date:	29 March 2016		
Next Inspection:	Not Applicable

Material Comments: Insulation board panel above door.

Action: No Action Required

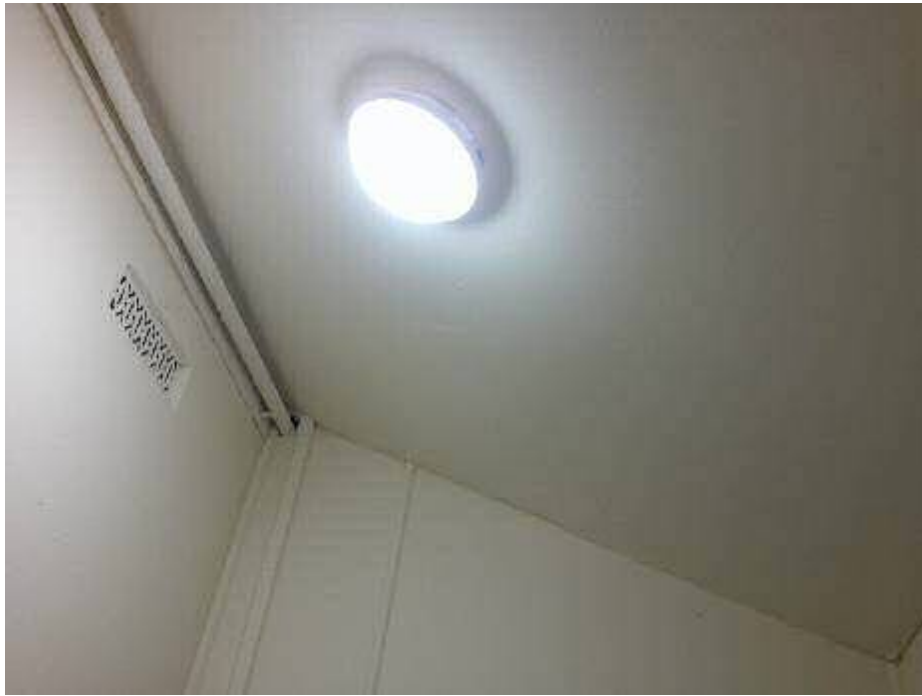
Location ID:	18408	Survey Type:	RI
Location Ref:	Visual ID to sample 2	Product Type:	Asbestos cement
Product:	Cement board	Damage:	Good condition
Area:	06	Treatment:	Asbestos cement sheets etc
Floor:	Ground floor	Asbestos Type:	Chrysotile
Room:	Womens Toilet	Identification:	Strongly Presumed as previous sample
Surveyor Name:	[REDACTED]	Quantity:	3m ²
Drawing Ref:	06		
Asbestos ?	Yes		
Date:	05 January 2023		
Next Inspection:	05 January 2024

Material Risk Score:	3
Material Risk Band:	Very Low Risk
Priority Risk Score:	4

Material Comments: **Ceiling panels. Plasterboard ceiling in place on 2023 re-inspection, based on evidence in the loft space strongly presumed still present above.**

Action: **Apply Warning Labels & Annually Re-Inspect**

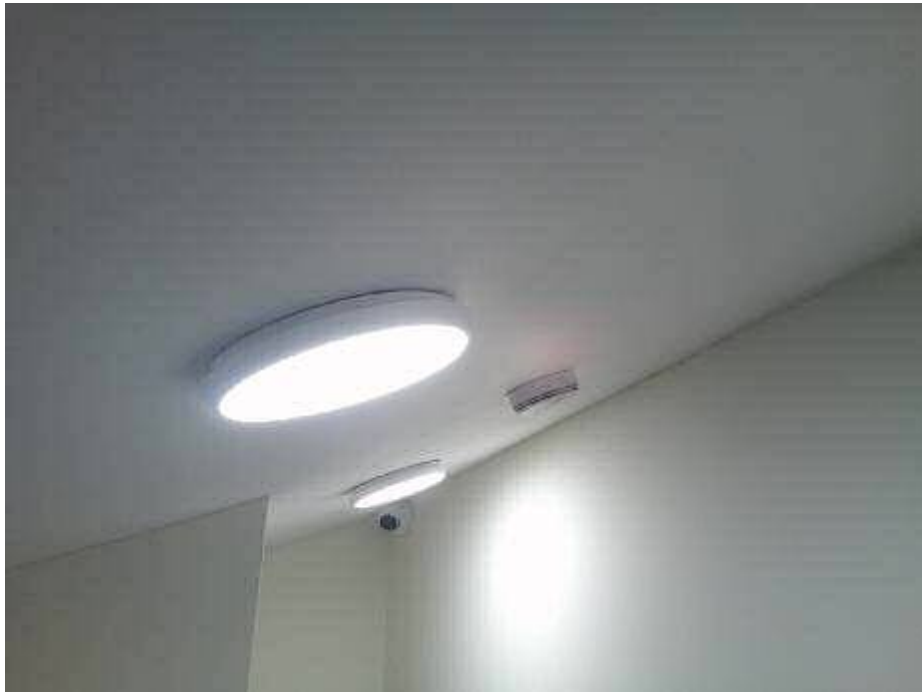
Location ID:	18409	Survey Type:	RI
Location Ref:	Visual ID to sample 2	Product Type:	Asbestos cement
Product:	Cement board	Damage:	Good condition
Area:	07	Treatment:	Asbestos cement sheets etc
Floor:	Ground floor	Asbestos Type:	Chrysotile
Room:	Circulation	Identification:	Strongly Presumed as previous sample
Surveyor Name:	[REDACTED]	Quantity:	6m ²
Drawing Ref:	07		
Asbestos ?	Yes		
Date:	05 January 2023		
Next Inspection:	05 January 2024

Material Comments: Ceiling panels. Plasterboard ceiling in place on 2023 re-inspection, based on evidence in the loft space strongly presumed still present above.

Action: Apply Warning Labels & Annually Re-Inspect

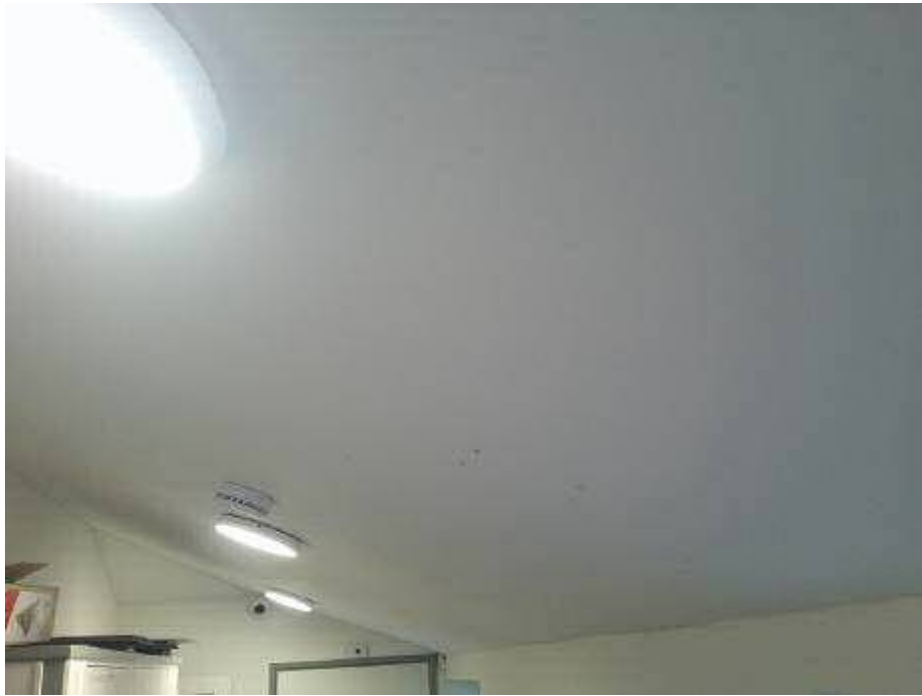
Location ID:	18410	Survey Type:	RI
Location Ref:	Visual ID to sample 2	Product Type:	Asbestos cement
Product:	Cement board	Damage:	Good condition
Area:	10	Treatment:	Asbestos cement sheets etc
Floor:	Ground floor	Asbestos Type:	Chrysotile
Room:	Circulation	Identification:	Strongly Presumed as previous sample
Surveyor Name:	[REDACTED]	Quantity:	14m ²
Drawing Ref:	10		
Asbestos ?	Yes		
Date:	05 January 2023		
Next Inspection:	05 January 2024

Material Risk Score:	3
Material Risk Band:	Very Low Risk
Priority Risk Score:	5

Material Comments: **Ceiling panels. Plasterboard ceiling in place on 2023 re-inspection, based on evidence in the loft space strongly presumed still present above.**

Action: **Apply Warning Labels & Annually Re-Inspect**

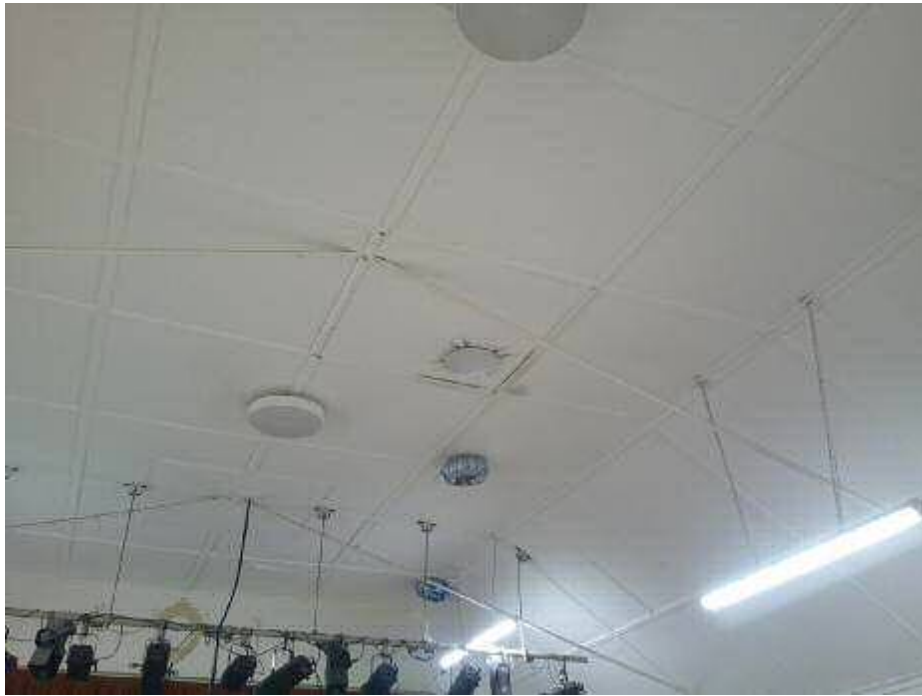
Location ID:	18411	Survey Type:	RI
Location Ref:	Visual ID to sample 2	Product Type:	Asbestos cement
Product:	Cement board	Damage:	Good condition
Area:	11	Treatment:	Asbestos cement sheets etc
Floor:	Ground floor	Asbestos Type:	Chrysotile
Room:	Hall	Identification:	Identified
Surveyor Name:	[REDACTED]	Quantity:	120m ²
Drawing Ref:	11		
Asbestos ?	Yes		
Date:	05 January 2023		
Next Inspection:	05 January 2024		
		Material Risk Score:	3
		Material Risk Band:	Very Low Risk
		Priority Risk Score:	5

Material Comments: **Ceiling panels.**

Action: **Apply Warning Labels & Annually Re-Inspect**

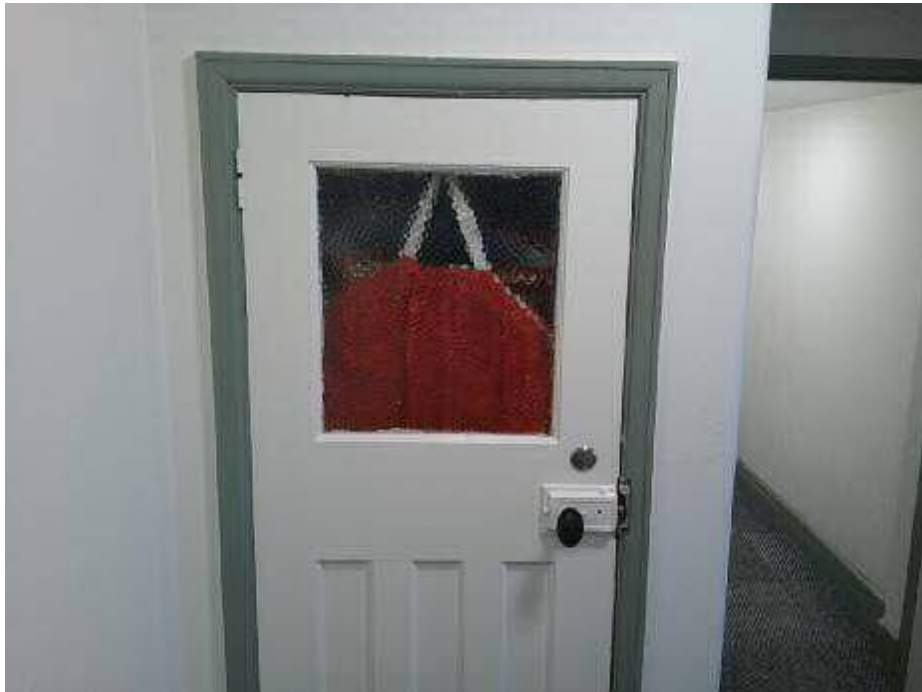
Location ID:	18412	Survey Type:	RI
Location Ref:	Visual ID to sample 2	Product Type:	Asbestos cement
Product:	Cement board	Damage:	Good condition
Area:	12	Treatment:	Asbestos cement sheets etc
Floor:	Ground floor	Asbestos Type:	Chrysotile
Room:	Mens Toilet	Identification:	Strongly Presumed as previous sample
Surveyor Name:	[REDACTED]	Quantity:	1m ²
Drawing Ref:	12		
Asbestos ?	Yes		
Date:	05 January 2023		
Next Inspection:	05 January 2024		
		Material Risk Score:	3
		Material Risk Band:	Very Low Risk
		Priority Risk Score:	4

Material Comments: Ceiling panels. Locked at time of inspection so presumed plasterboard ceiling in place on 2023 re-inspection, based on evidence in the loft space strongly assumed still present above.

Action: Apply Warning Labels & Annually Re-Inspect

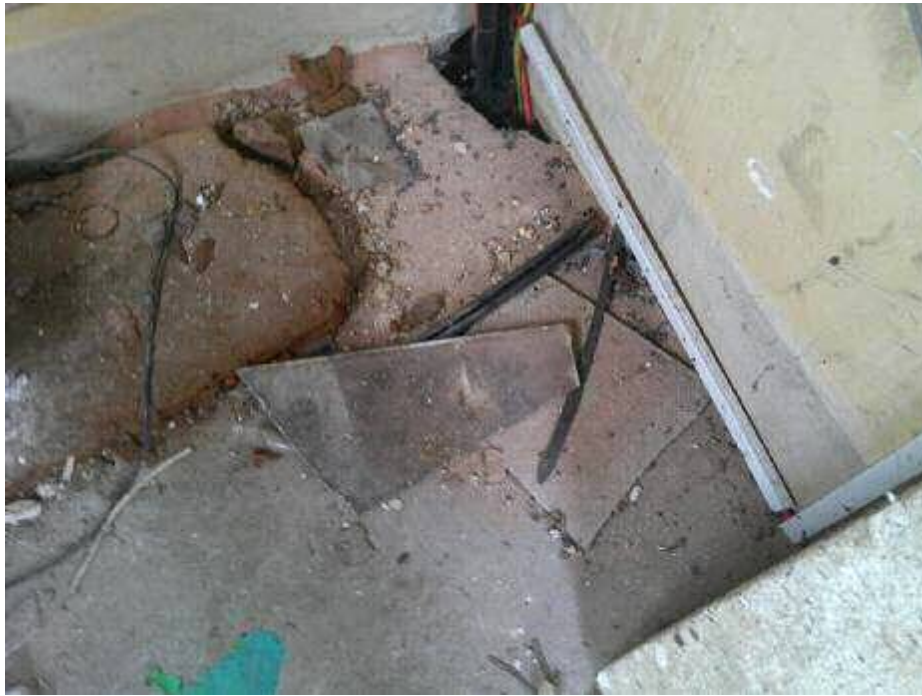
Location ID:	18414	Survey Type:	RI
Location Ref:	Visual ID	Product Type:	Asbestos cement
Product:	Cement board debris	Damage:	High damage
Area:	18	Treatment:	Debris
Floor:	Roof	Asbestos Type:	Chrysotile
Room:	Projector room	Identification:	Strongly Presumed
Surveyor Name:	[REDACTED]	Quantity:	Small
Drawing Ref:	18		
Asbestos ?	Yes		
Date:	05 January 2023		
Next Inspection:	05 January 2024

Material Comments: Asbestos cement debris to floor of projector room.

Action: Remove & Dispose Of As Hazardous Waste

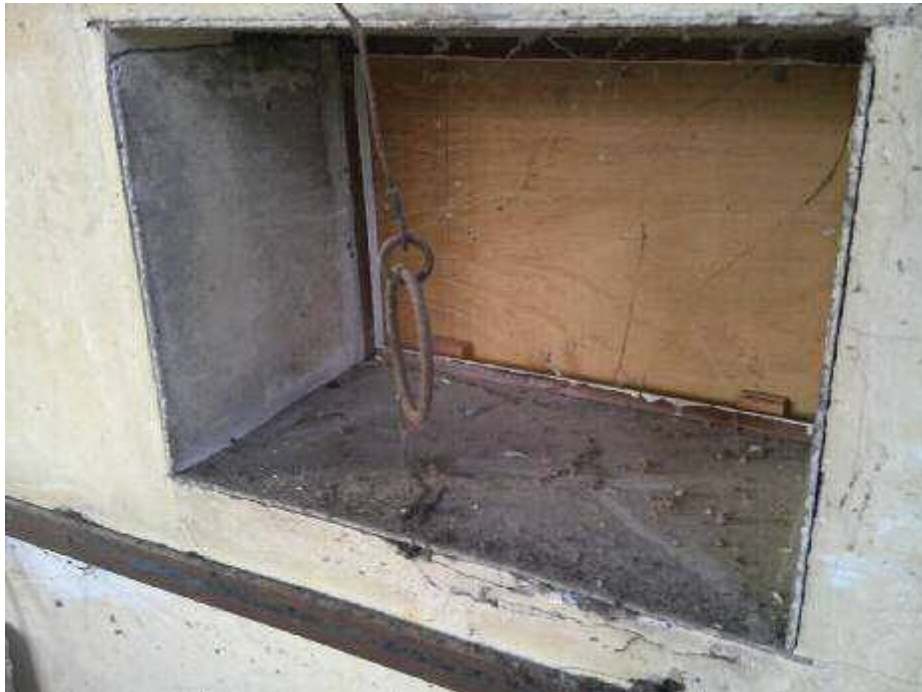
Location ID:	18413	Survey Type:	RI
Location Ref:	Visual ID	Product Type:	Asbestos cement
Product:	Cement board	Damage:	Low damage: Scratches or marks
Area:	18	Treatment:	Asbestos cement sheets etc
Floor:	Roof	Asbestos Type:	Chrysotile
Room:	Projector room	Identification:	Strongly Presumed
Surveyor Name:	[REDACTED]	Quantity:	1m ²
Drawing Ref:	18		
Asbestos ?	Yes		
Date:	05 January 2023		
Next Inspection:	05 January 2024		
		Material Risk Score:	4
		Material Risk Band:	Very Low Risk
		Priority Risk Score:	1

Material Comments: Lining panels to voids in wall.

Action: Apply Warning Labels & Annually Re-Inspect

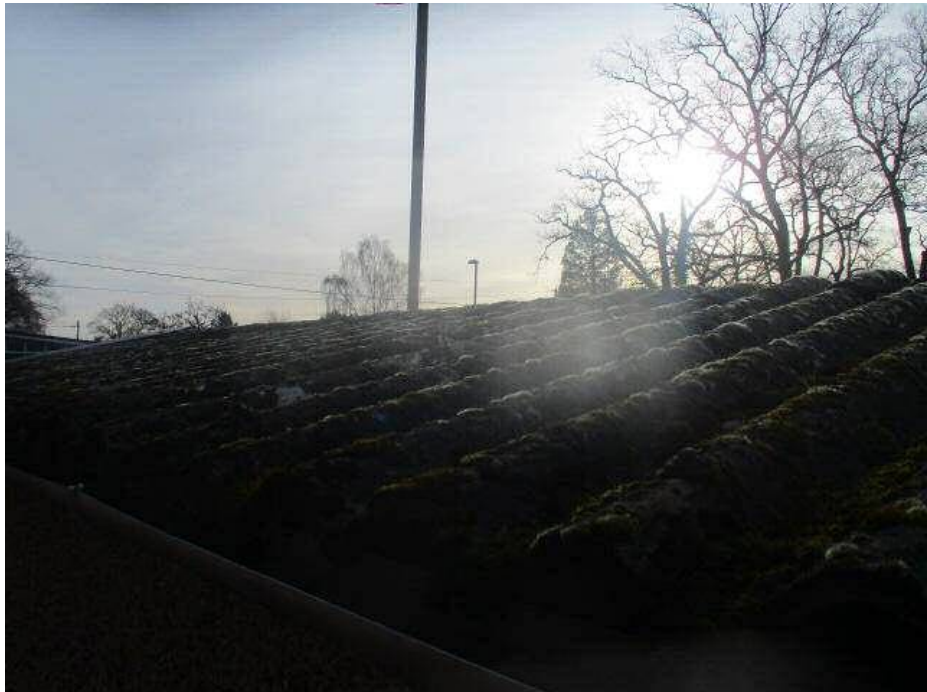
Location ID:	71884	Survey Type:	RI
Location Ref:	Sample 5 (AS10120)	Product Type:	Asbestos cement
Product:	Cement Roof Sheets	Damage:	Good condition
Area:	19	Treatment:	Asbestos cement sheets etc
Floor:	External	Asbestos Type:	Chrysotile
Room:	External	Identification:	Identified
Surveyor Name:	[REDACTED]	Quantity:	16m ²
Drawing Ref:	19		
Asbestos ?	Yes		
Date:	03 February 2023		
Next Inspection:	03 February 2024		
		Material Risk Score:	3
		Material Risk Band:	Very Low Risk
		Priority Risk Score:	4

Material Comments: **Cement roof sheets to shed directly outside exit of area 20.**

Action: **Annually Re-Inspect**

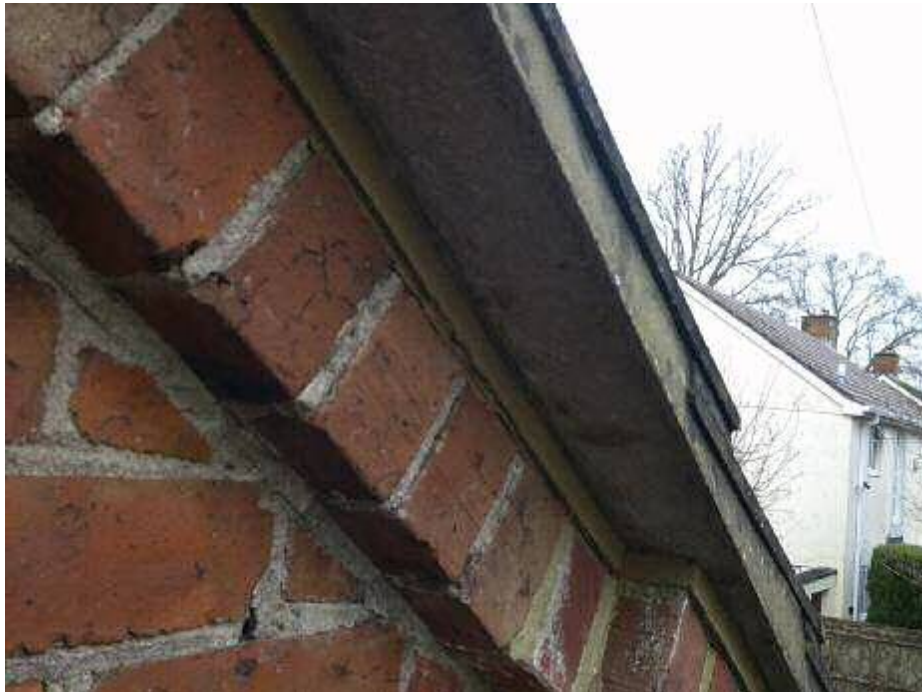
Location ID:	18415	Survey Type:	RI
Location Ref:	Visual ID	Product Type:	Asbestos cement
Product:	Undercloaking	Damage:	Good condition
Area:	19	Treatment:	Asbestos cement sheets etc
Floor:	External	Asbestos Type:	Chrysotile
Room:	General externals	Identification:	Strongly Presumed
Surveyor Name:	██████████	Quantity:	20 Linear Metres
Drawing Ref:	19		
Asbestos ?	Yes		
Date:	05 January 2023		
Next Inspection:	05 January 2024		
		Material Risk Score:	3
		Material Risk Band:	Very Low Risk
		Priority Risk Score:	3

Material Comments: **Asbestos cement board undercloaking to both gable ends.**

Action: **Annually Re-Inspect**

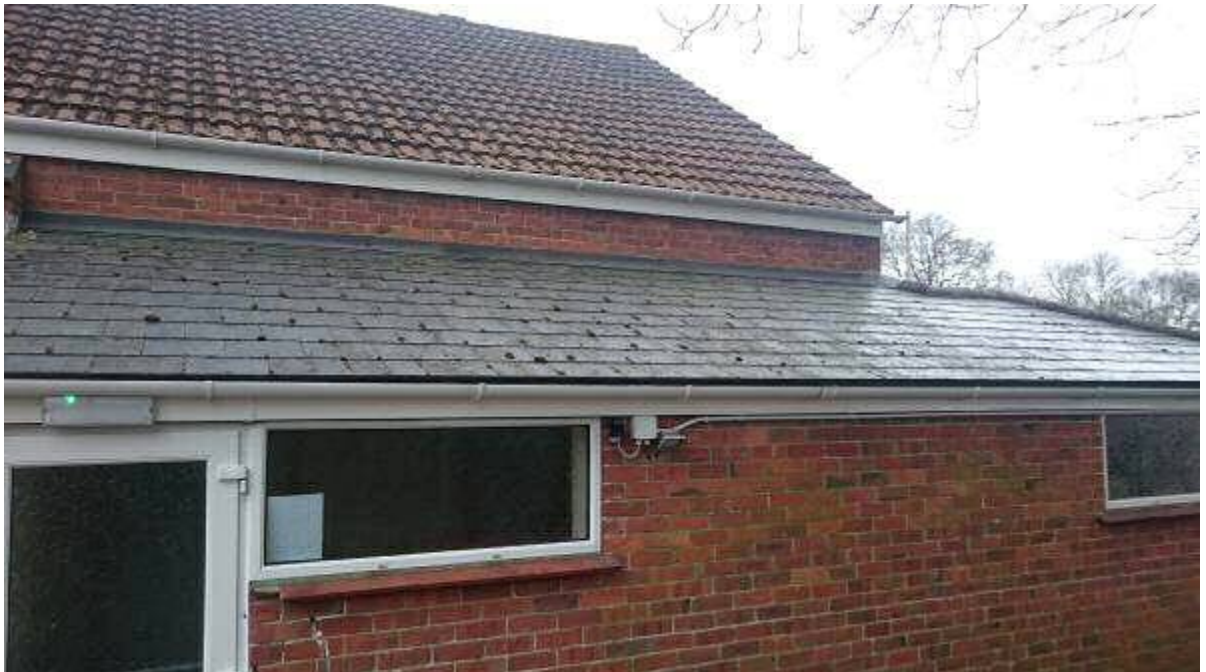
Location ID:	18416	Survey Type:	MS
Location Ref:	Sample 4	Product Type:	NADIS
Product:	Roof Slates	Damage:	NADIS
Area:	19	Treatment:	NADIS
Floor:	External	Asbestos Type:	NADIS
Room:	General externals	Identification:	Identified
Surveyor Name:	[REDACTED]	Quantity:	20m ²
Drawing Ref:	19		
Asbestos ?	No		
Date:	29 March 2016		
Next Inspection:	Not Applicable

Material Risk Score:	0
Material Risk Band:	NADIS
Priority Risk Score:	N/A

Action: **No Action Required**

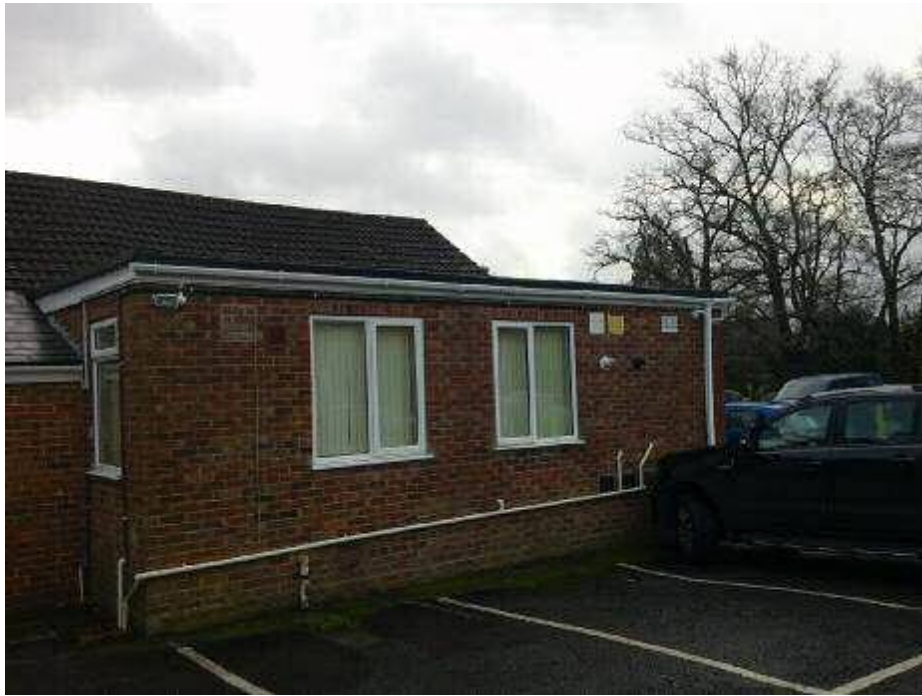
Location ID:	18417	Survey Type:	RI
Location Ref:	Visual ID	Product Type:	NADIS
Product:	Cement flue pipe	Damage:	NADIS
Area:	19	Treatment:	NADIS
Floor:	External	Asbestos Type:	NADIS
Room:	General externals	Identification:	Identified
Surveyor Name:	[REDACTED]	Quantity:	1 Linear Metres
Drawing Ref:	19		
Asbestos ?	No		
Date:	05 January 2023		
Next Inspection:	Not Applicable

Material Comments: Asbestos cement flue pipe and chimney cowl. Found to have been removed on 2023 re-inspection.

Action: No Action Required

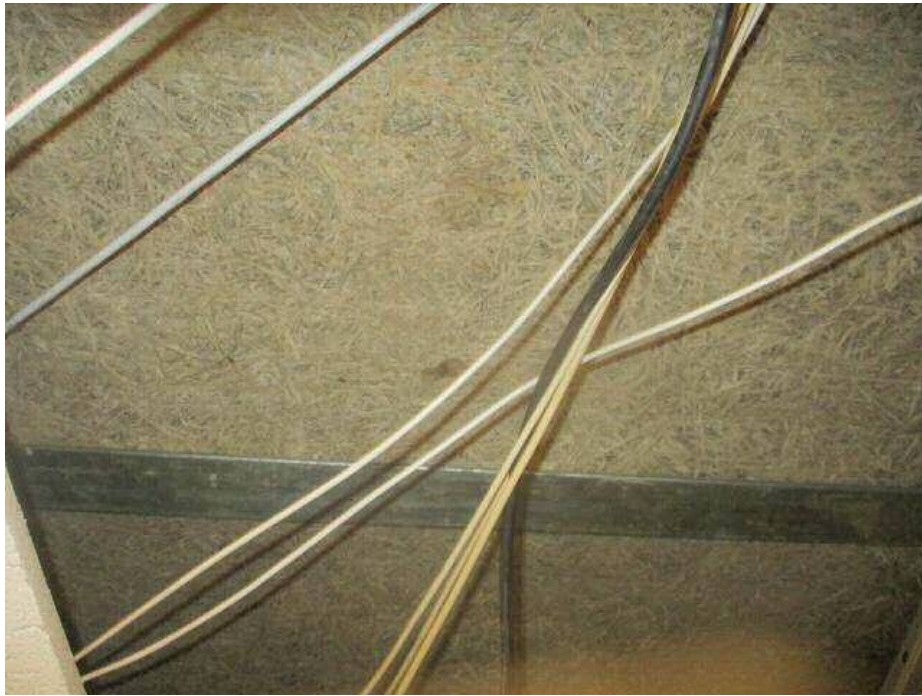
Material Risk Score:	0
Material Risk Band:	NADIS
Priority Risk Score:	N/A

Material Comments: **Stramit board present above suspended ceiling and overlapping into adjoining areas in ceiling void.**

Action: **No Action Required**

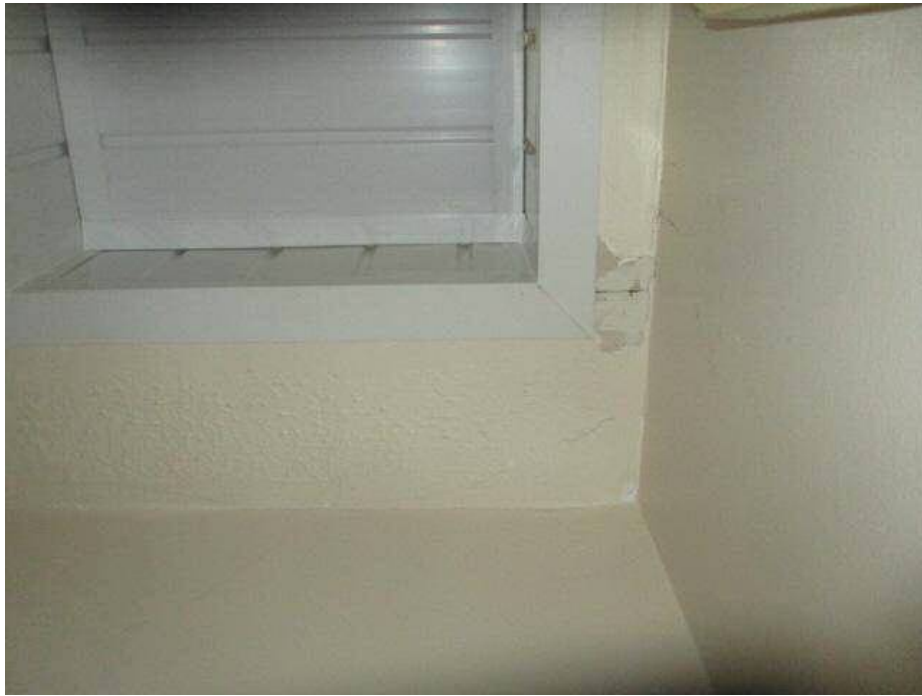
Material Risk Score:	4
Material Risk Band:	Very Low Risk
Priority Risk Score:	4

Material Comments: Textured coating to plasterboard ceiling.

Action: Encapsulate Damaged Areas & Annually Re-Inspect

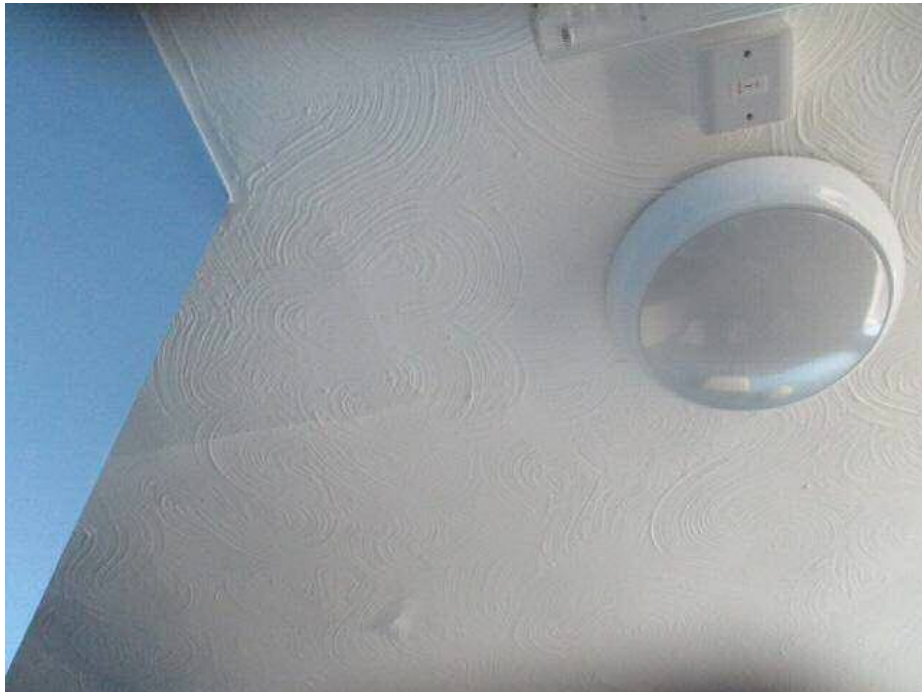
Material Comments: Textured coating to plasterboard ceiling.

Action: No Action Required

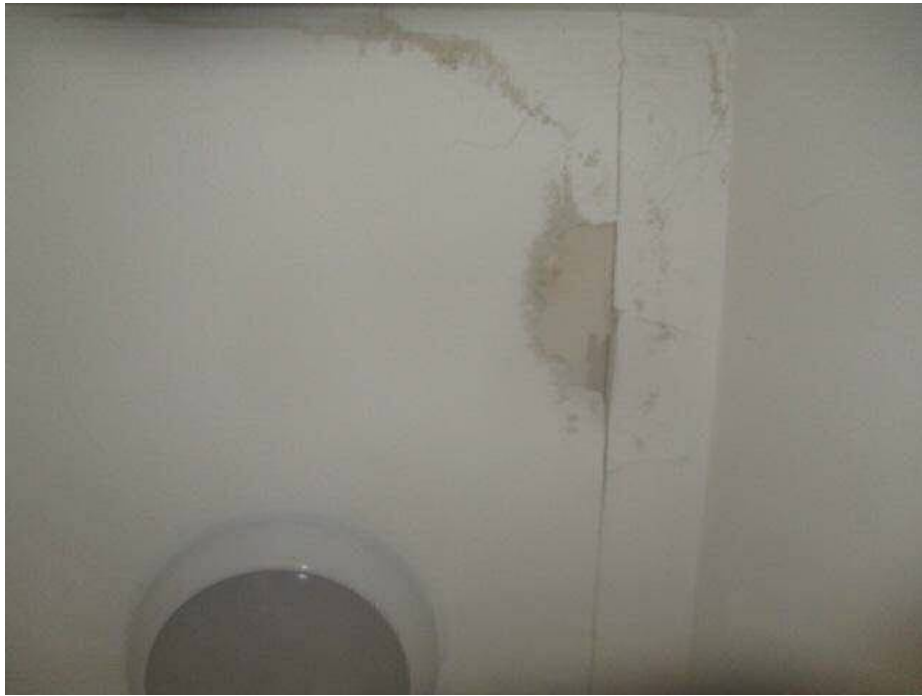
Material Risk Score:	0
Material Risk Band:	NADIS
Priority Risk Score:	N/A

Material Comments: **Textured coating to plasterboard ceiling.**

Action: **No Action Required**

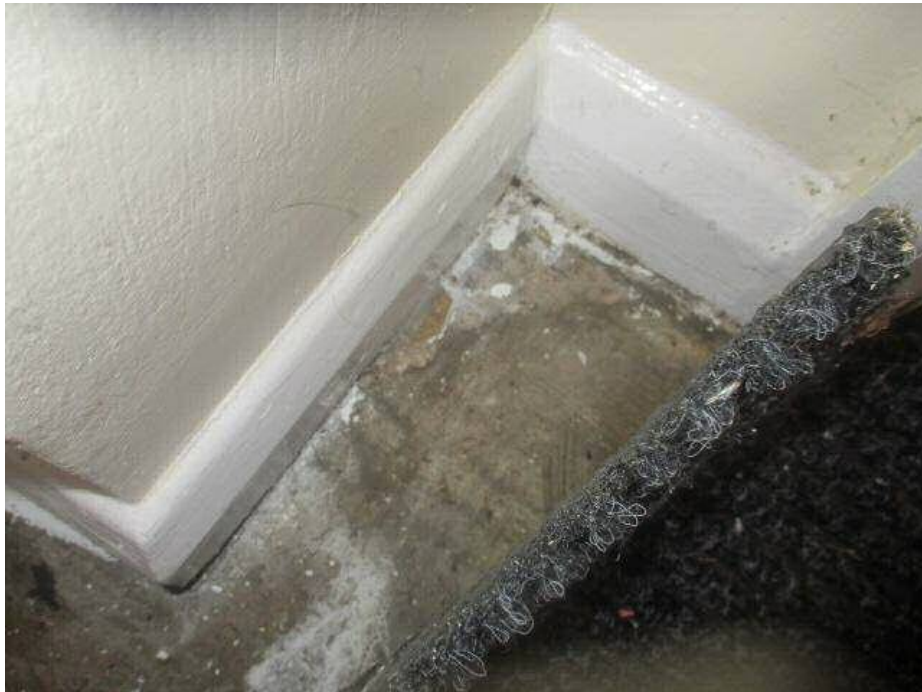
Material Comments: Floor tiles under fitted carpet.

Action: No Action Required

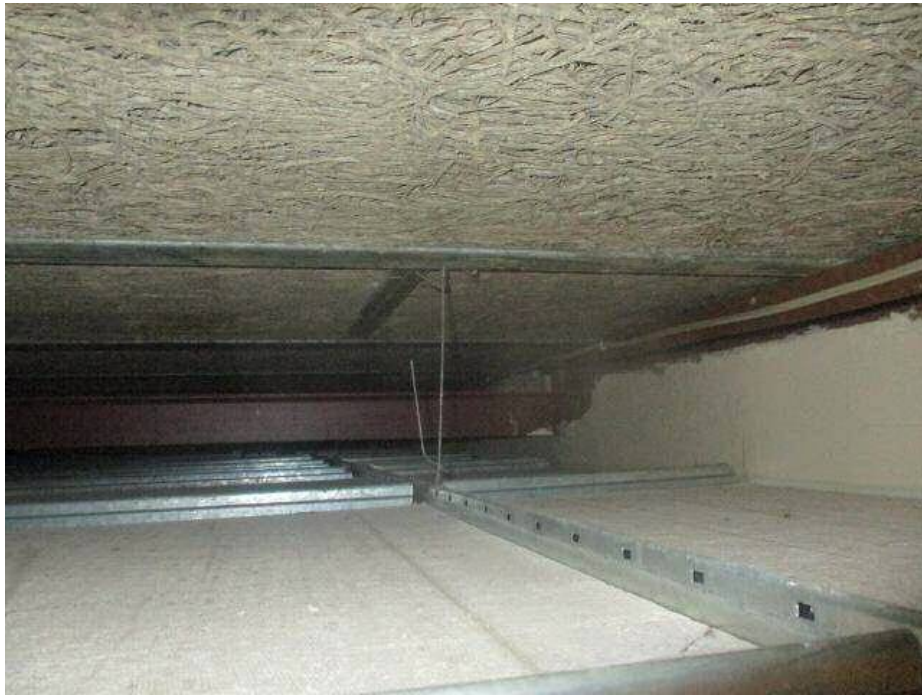
Material Comments: **Void above suspended ceiling accessed in multiple areas. No ACM's present where inspected.**

Action: **No Action Required**
