PLAY AREA SAFETY INSPECTION REPORT

Chideock Parish Council

Park Name: Mill Lane
Location: Mill Lane, Chideock. DT6 6JS

Inspection undertaken September 2023
This report issued 2nd November 2023

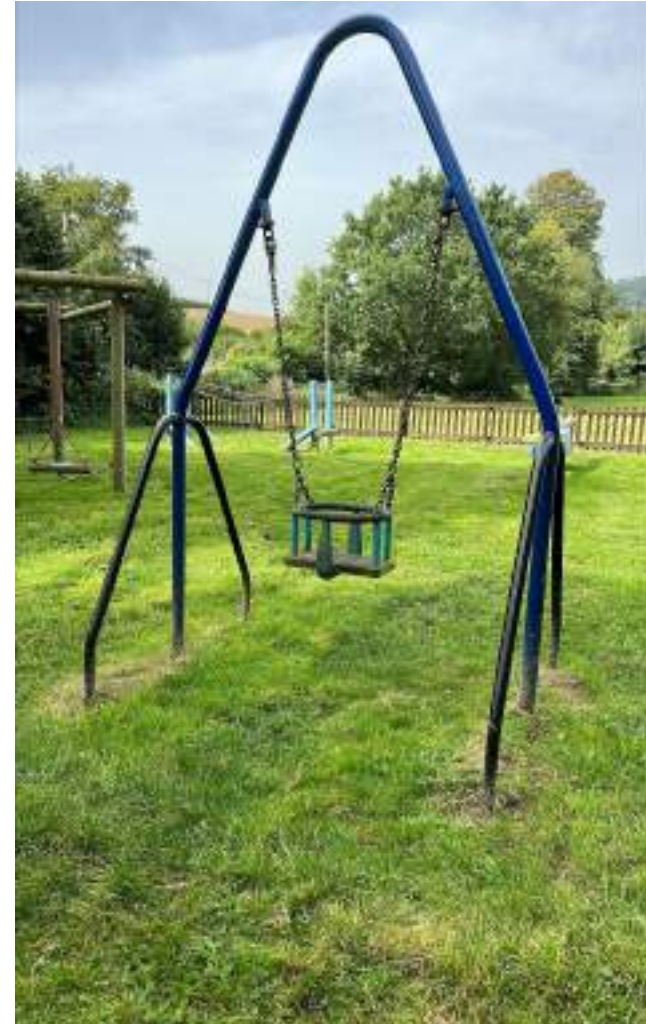
4.2 Toddler Swing

This item is in reasonable condition but plans should be made to replace the seat in the next 12 – 18 months.

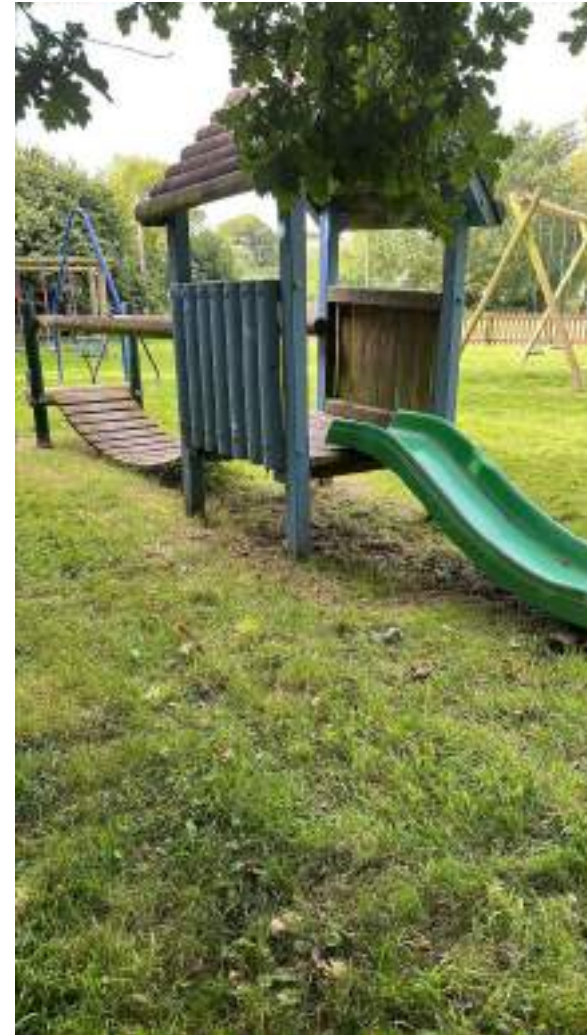
4.3 *Playhouse with bridge & Slide*

This item is in reasonable condition for its age.

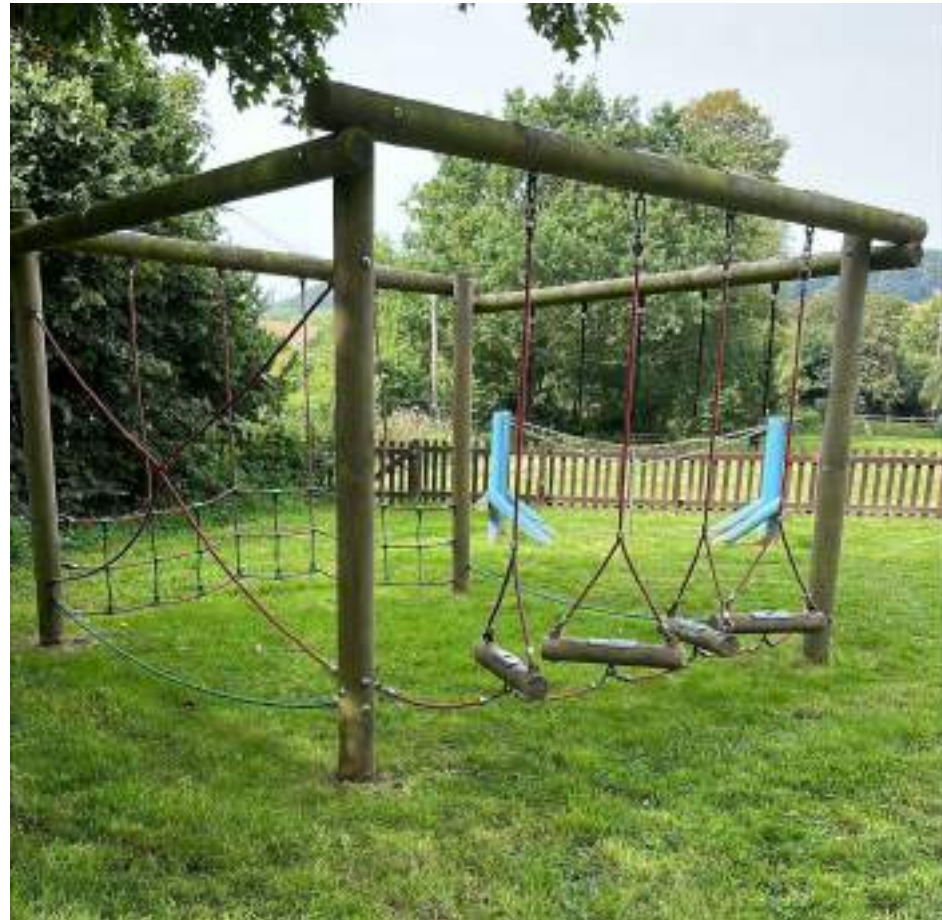
4.4 Sovereign Agility Cube

There are no issues with this unit, but timber elements should be regularly treated against decay.

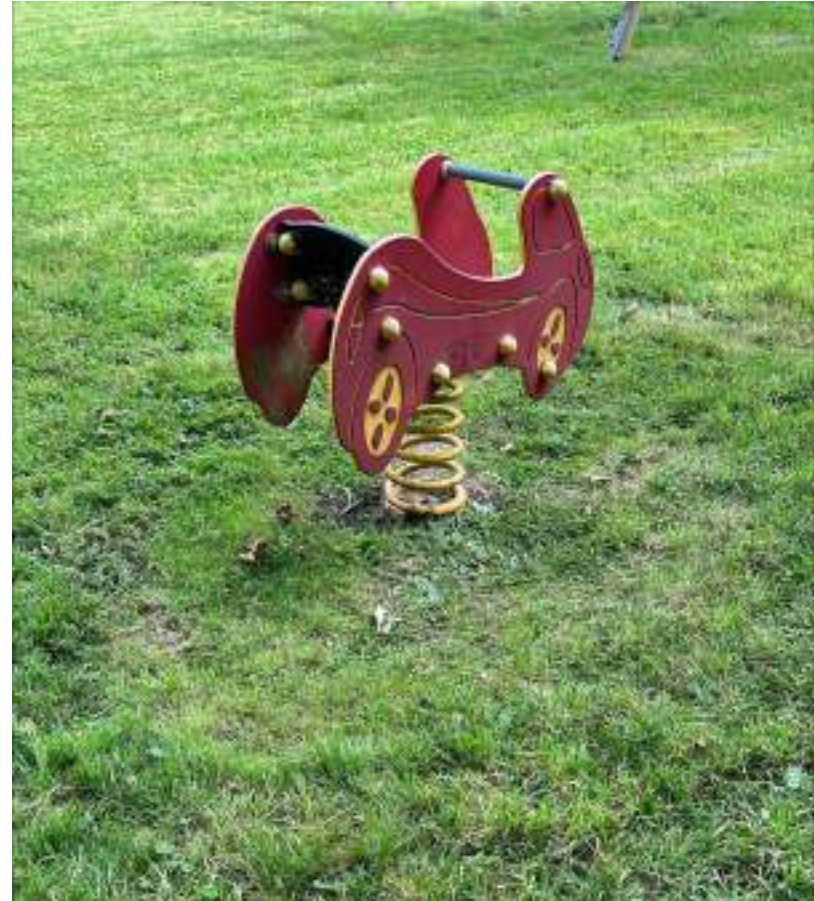
4.5 *Sit in Car Springer*

There is a great of corrosion on the base plates for this unit. Replacement of these components is possible, and costs are shown at 5.

Item	Issues	Recommendation (s)
4.5	The decay in the springer base plate will lead to product failure	Plan for removal and replacement within 2.5 years / possibility of replacement of parts only.
4.8	Timbers are decaying	Replace older timber elements within 2 years. Treat all existing timbers
4.11	Loose gate post	Repair

Item	Issues	Recommendation (s)	Supply Only	Supply & fit
4.5	Springer corroding	Replace parts		£450.00
4.8	Original timbers decaying	Supply and fit new timbers to Burmese bridge		POA

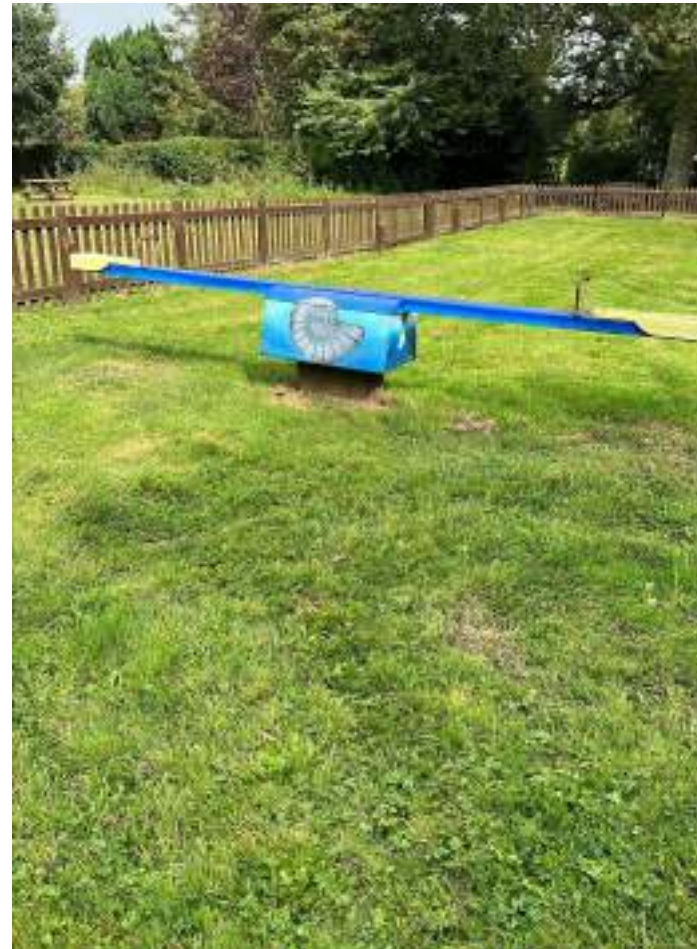
4.6 **Wicksteed See saw**

This Wicksteed see-saw is still in good working order.

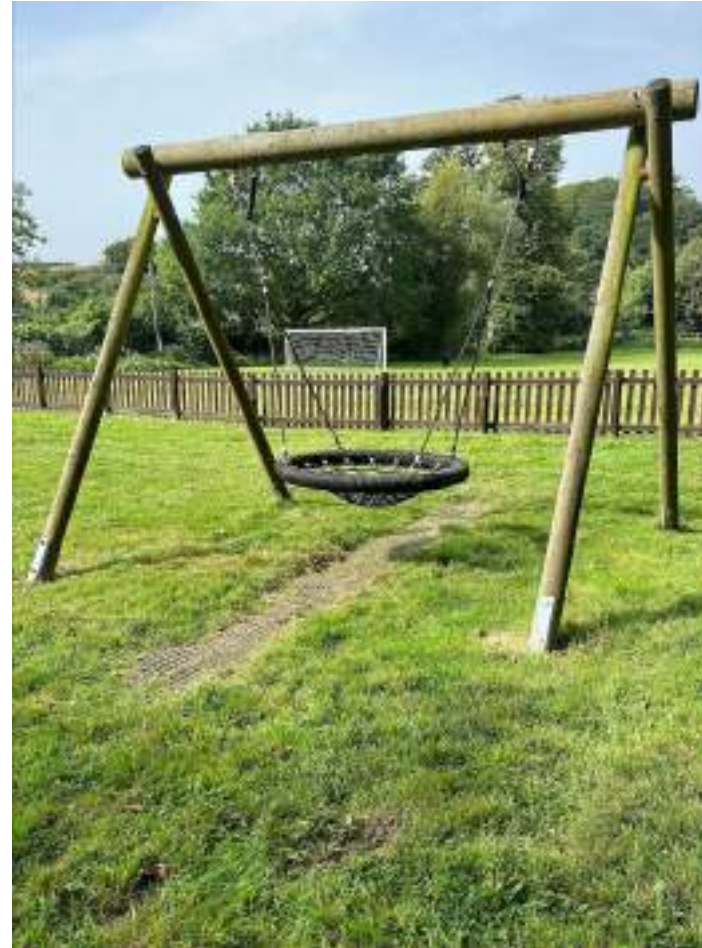
4.7 *Caledonian Play Basket Swing*

This item is in good condition.

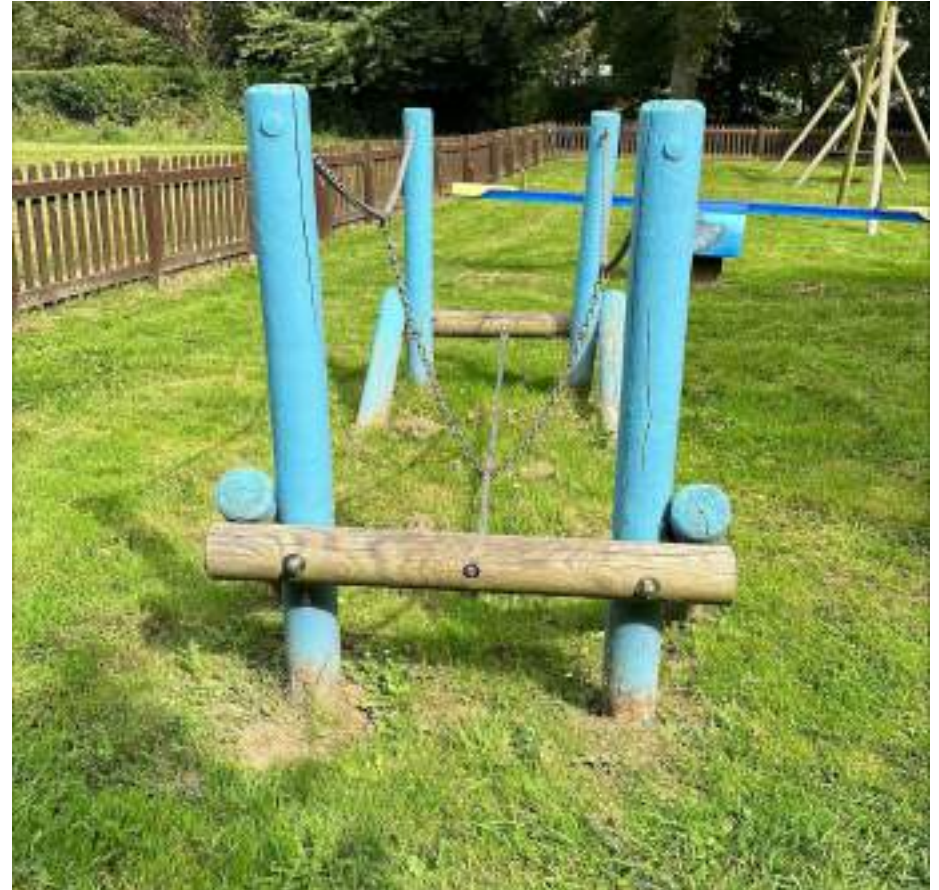
4.8 *Playquest Burmese Bridge*

This item is in reasonable condition for its age, but the remaining timbers will need replacing soon.

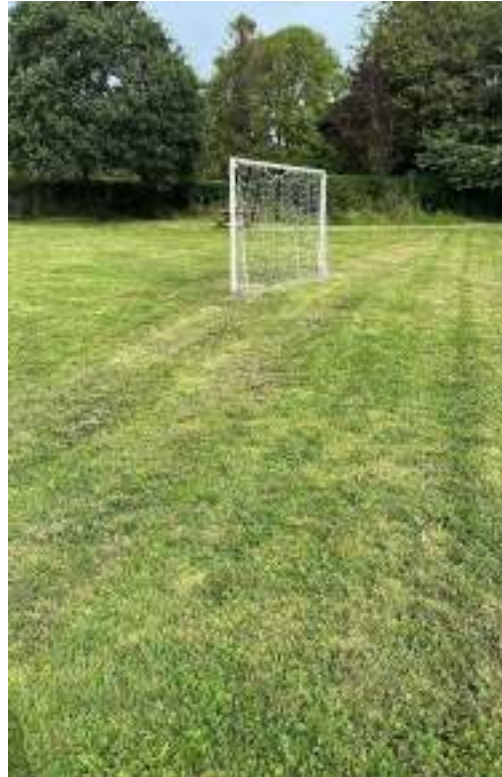
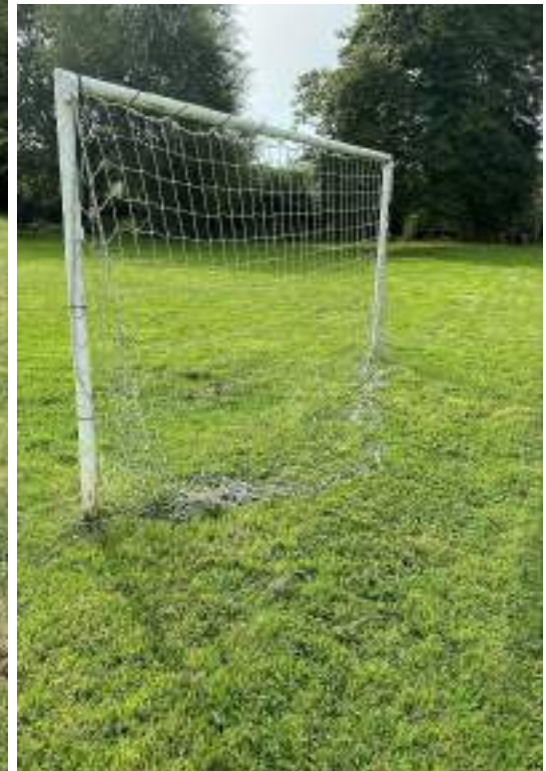
4.9 Goalposts

The goals are due to be replaced with a fixed net style set.

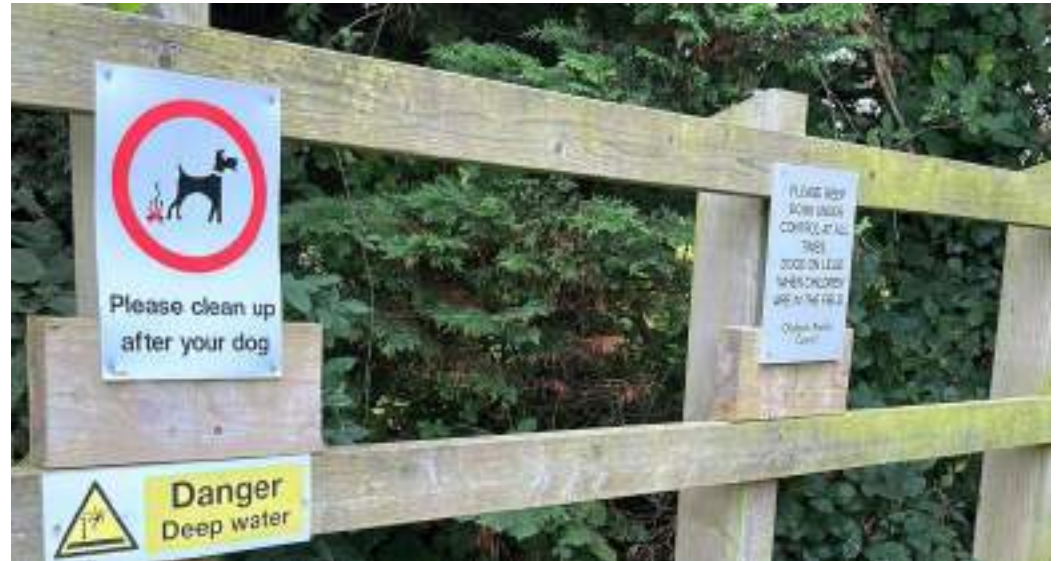
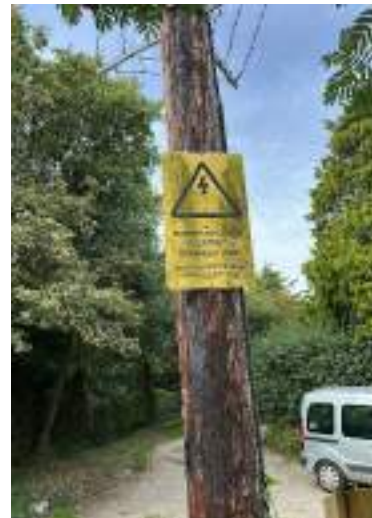
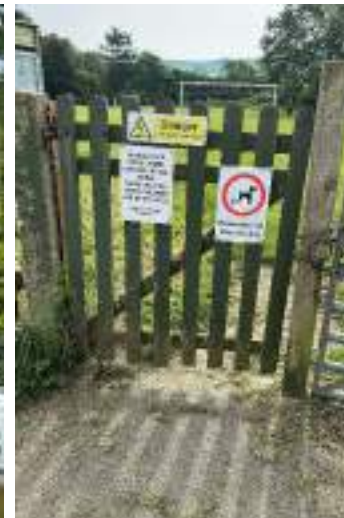
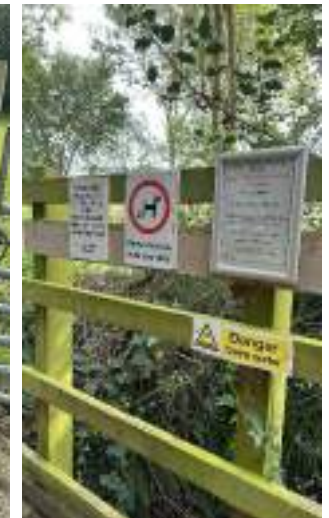
4.10 Signs

Suitable signage is in place.

Warnings against deep water and overhead power cables are also present.

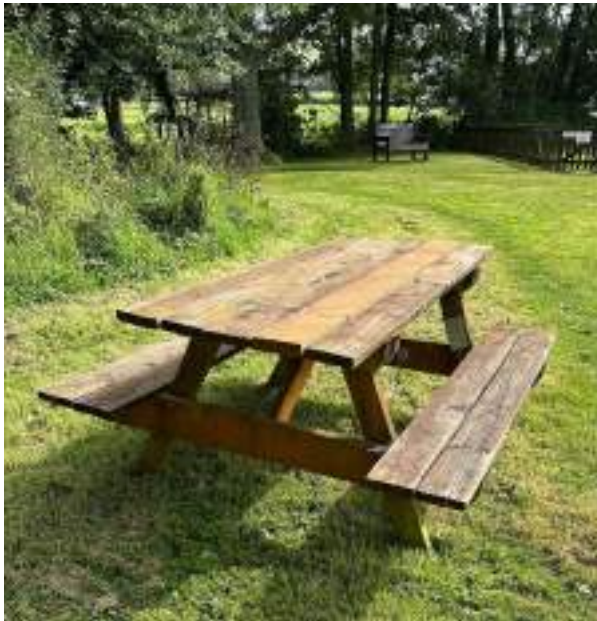
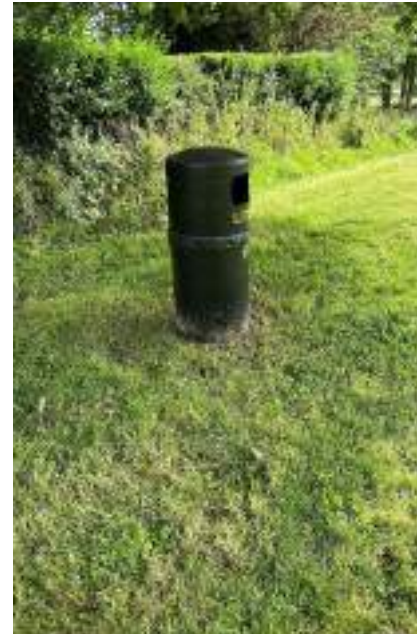
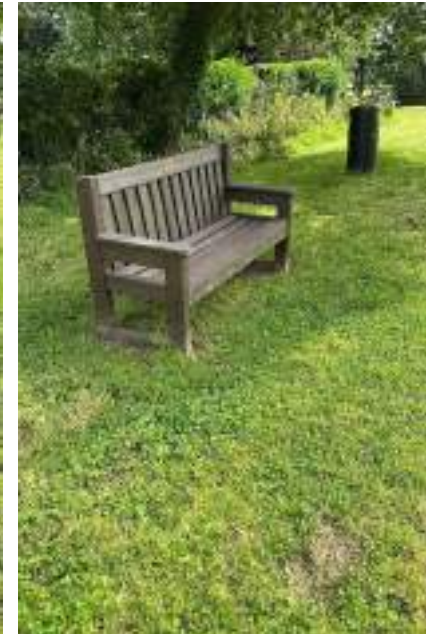
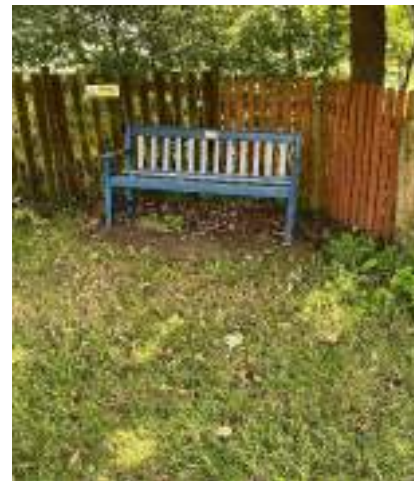
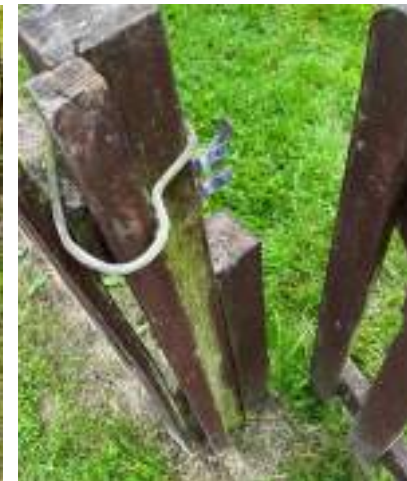
4.11 Barriers, Boundaries, Benches & Bins

The gates are self-closing, and the mechanism is working effectively.

One of the posts on the right-hand gate (seawards) is loose in the ground.

There are several nearby bins and a variety of benches around the site in reasonable condition.
