MINUTES OF MEETING OF AMENITIES COMMITTEE
24 June 2024
10:00, Woolton Hill Church Hall

REVIEW OF THE PARISH FIELD

REVIEW OF THE PARISH FIELD: PART 2

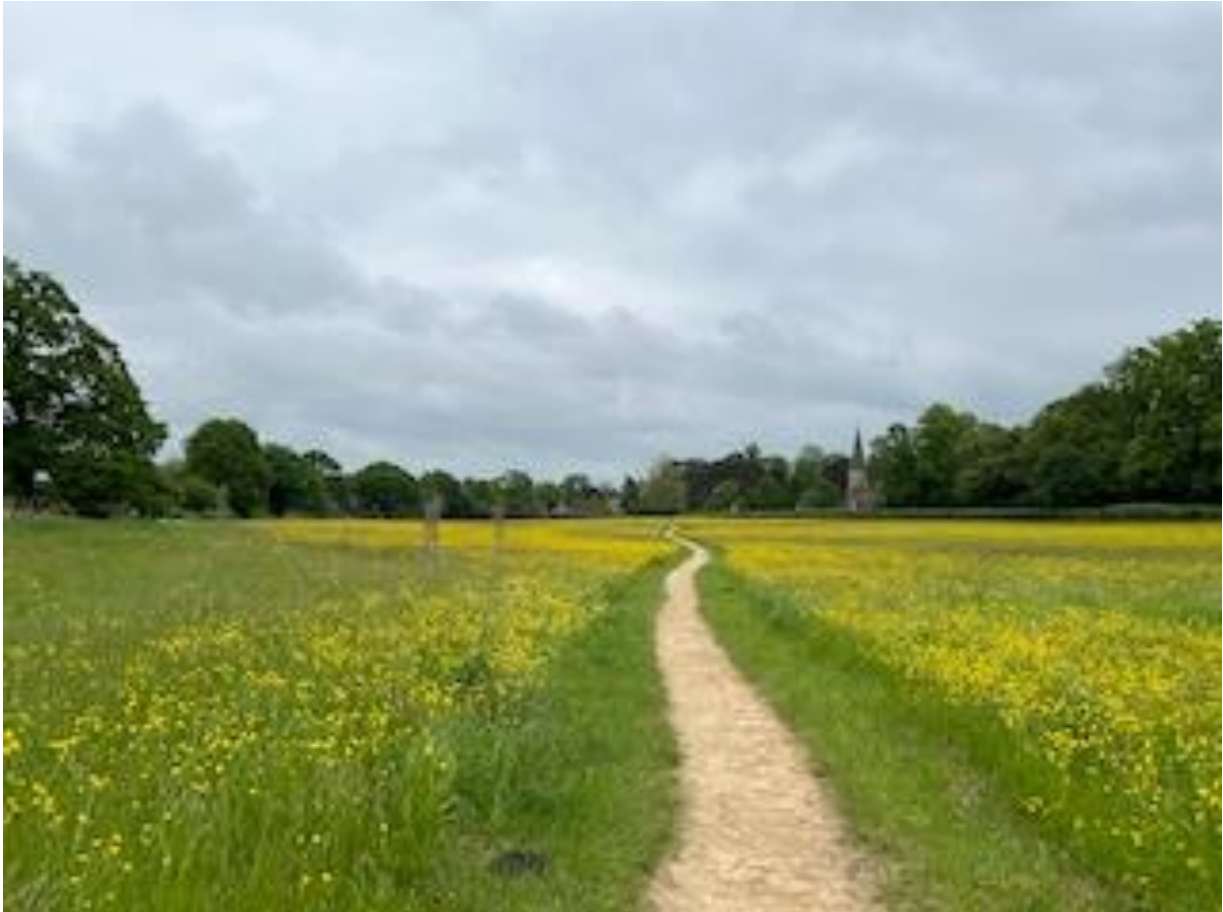
Photo: 4777

View of the Parish Field from the entrance gate at the south west corner. It is apparent that the profile of the field is a slight curve so that the path lies at the lowest point and the land rises from the path to the western and eastern boundaries. The predominance of buttercups looks attractive in mid May but inhibits the establishment of other species.

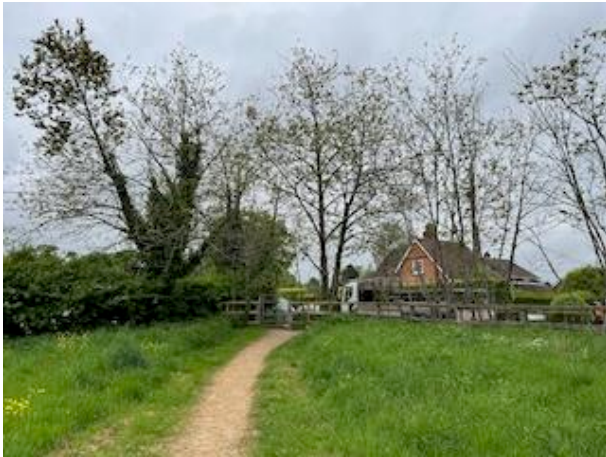
Photo No.4776

This photo looks south along the path towards the entrance gate at the south west corner. Two large cherry trees on the boundary with Copnor either side of the gate are in poor condition being covered in ivy (which should be removed) with dead wood (which also should be removed). Another tree near the gate but outside the field has fungal growth that could be honey fungus. The smaller cherry trees are outside the fence line.

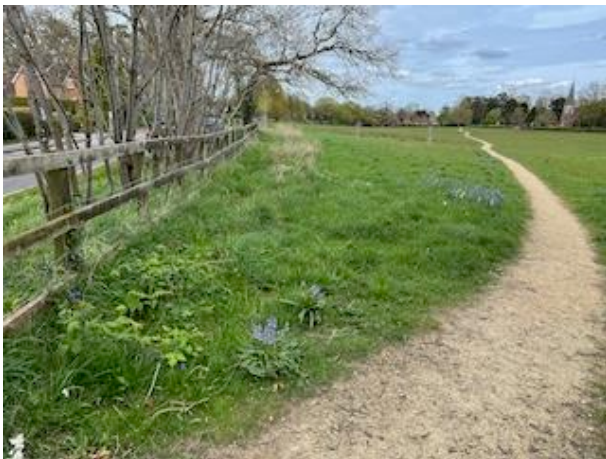
Photo No.4721

This photo looks north along the western boundary from the gate at the south end. Between the gate and the house called Chancer's Barn, the boundary is formed by a post and rail fence with wire sheep netting but with no hedge. There is a row of small cherry trees outside the fence some of which have branches which hang over the field.

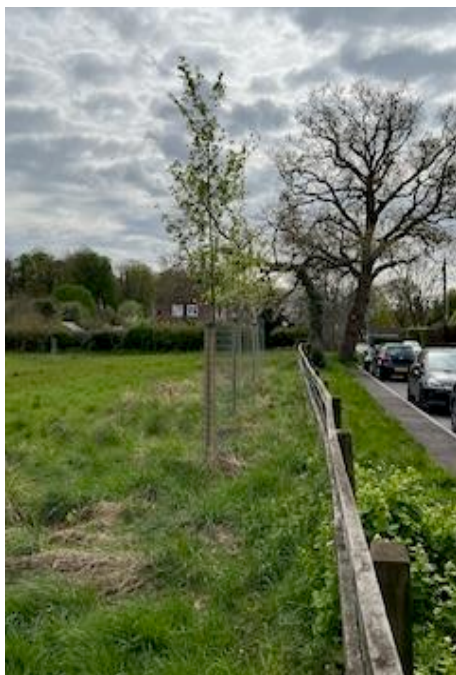
Photo No.4722

When the additional on-street parking for the doctors' surgery was created in 2023, a large tree on the line of the fence was removed, the ditch was culverted and three new ornamental pear trees were planted in the field by the contractors rather too close to the fence and too close together. The post and rail fence was repaired but it is not in good condition.

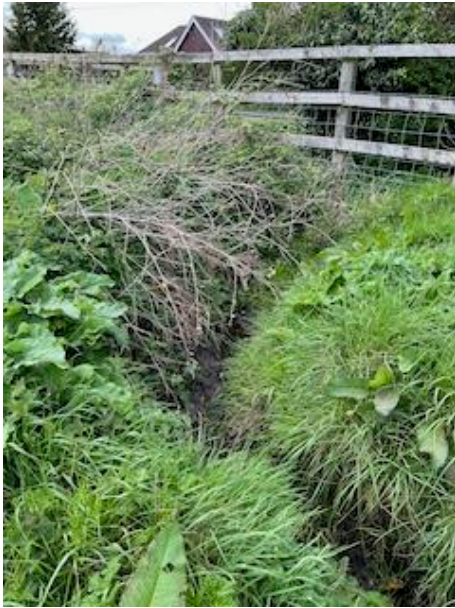
Photo: 4726

The ditch emerges from the culvert under the verge opposite the doctors' surgery and enters the field. At this point, the ditch is about 1 metre wide and 1 metre deep. It appears to carry a considerable amount of water when there is rain, although there was little flow after two days without rain.

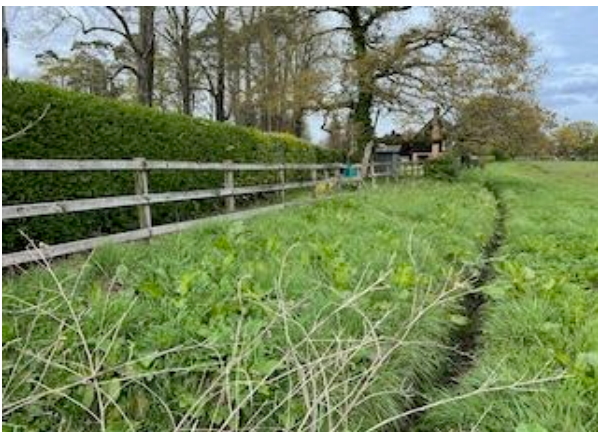
Photo: 4725

The ditch continues in a northerly direction parallel to the western boundary about 3 metres into the field from the fence. By the time the ditch is adjacent to Chancer's Barn, it is shallower, but continues parallel with the western boundary.

Part of the boundary with Chancer's Barn comprises a post and rail fence behind which is a substantial hedge. The post and rail fence is not in good condition with some broken rails.

There is a substantial oak tree in the garden of Chancer's Barn close to the boundary with several branches overhanging the field.

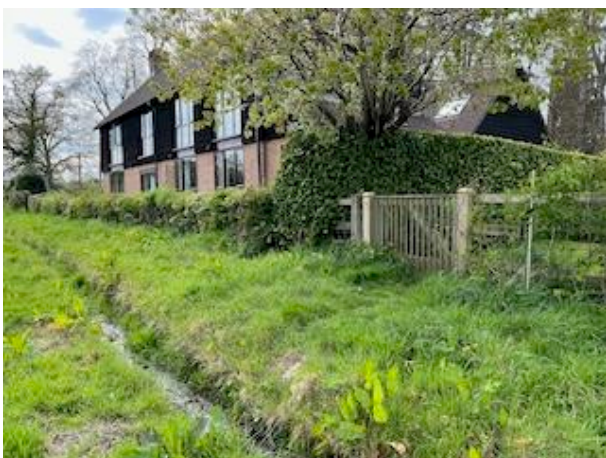
Photo: 4731

Chancer's Barn is close to the boundary. In front of the house, there is a mixed species hedge which has been kept trimmed low (a height of about 1.5 metres). There is a substantial laurel hedge from the fence (at least 2m high and over 1m wide] between Chancer's Barn and Fairfield the end of which is on the boundary of the field. The ditch at this point is about 3 metres into the field from the hedge.

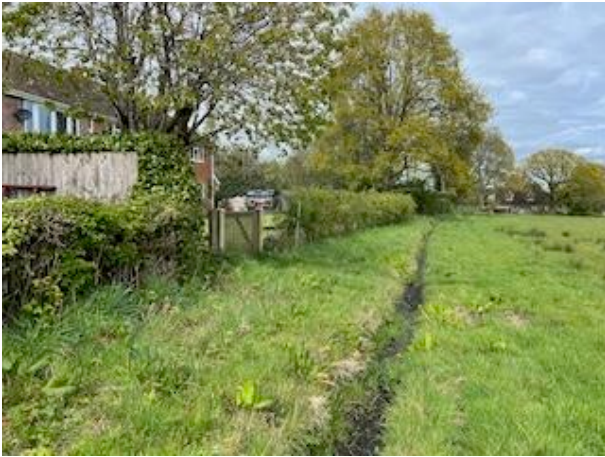
Photos: 4729 and 4730

The boundary with Fairfield is mainly a hedge, but there is gate from the garden into the field. There is a medium size tree within the garden of Fairfield which overhangs the field.

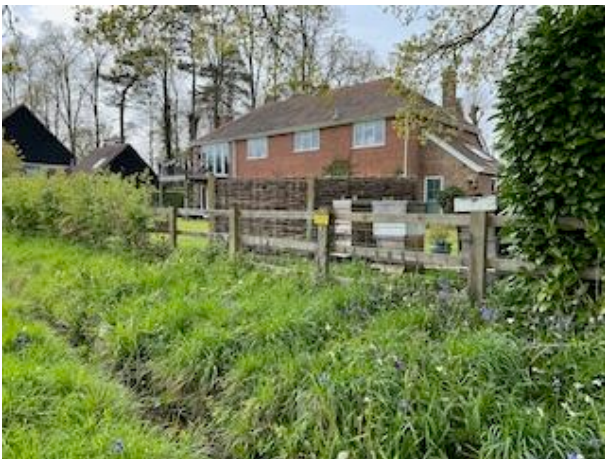
Photo: 4732

Part of the boundary with Fairfield is a hedge (which appears to have been planted relatively recently) and part of the boundary is a post and rail fence without any hedge. Bee hives are being kept adjacent to the boundary where there is no hedge. There is a substantial laurel hedge on the boundary between Fairfield and Halesworth. The ditch continues parallel with the boundary but at this point the distance between the ditch and the boundary is only about 1.5m.

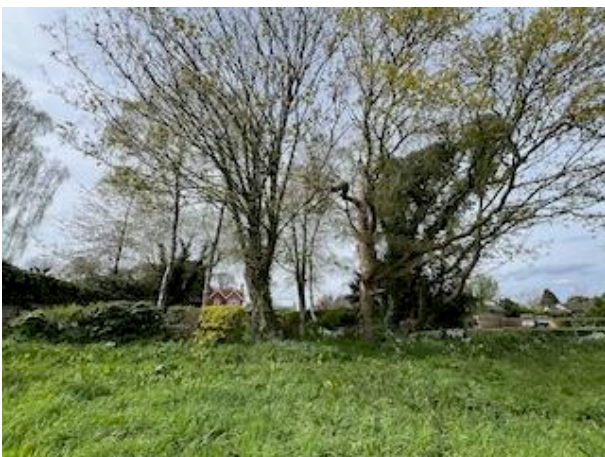
Photo: 4736

This photo shows the boundary between Oakleigh and the field. There is a hedge and a dilapidated white 'palisade' fence. There are several large trees on or close to this boundary. One tree is in the hedge on the (assumed) boundary, but the remainder are within the garden of Oakleigh. One of the trees in the garden of Oakleigh is dead and another is covered with ivy (see photo 4738 below).

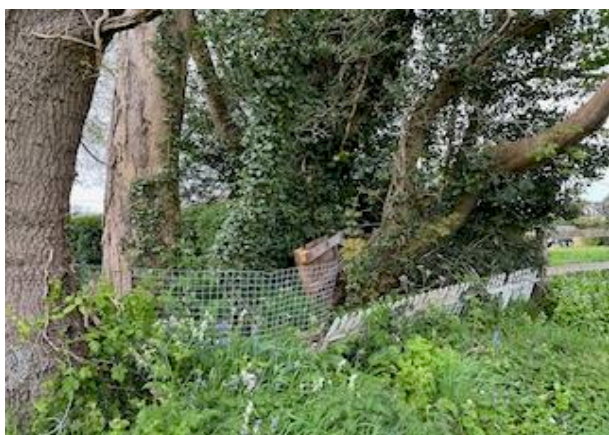
Photo: 4738

This photo shows part of the boundary between Oakleigh and the field. See also photo 4736.

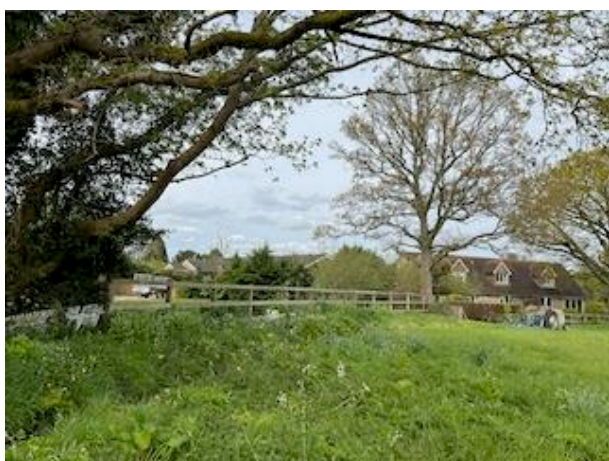
Photo: 4737

The boundary between the field and Casablanca (Old Shop) is a post and rail fence with no hedge. There is a substantial oak tree on the boundary of the field just within the garden of Casablanca (Old Shop) (see also photo 4739).

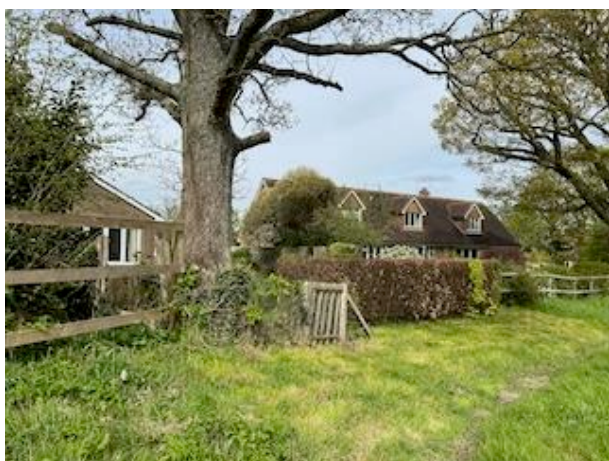
Photo: 4739

There is a large oak tree which seems to be within the hedge which forms the boundary between Casablanca and Mannin West and on the boundary between those houses and the field. There is gate into the field from the garden of Mannin West. Some of the branches overhang the field. The ditch at this point is merely a shallow line in the grass.

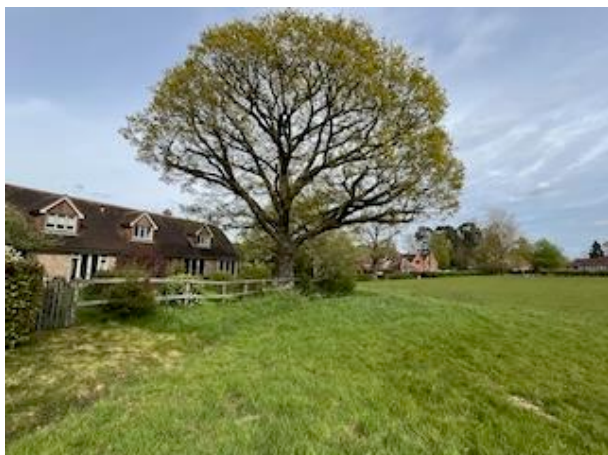
Photo: 4742

This photo shows the boundary between the field and Belle Vue South which is formed by a post and rail fence with some shrubs. There is a fine oak tree close to the boundary although the post and rail fence has been placed so the tree is within the garden of Belle Vue South. Its branches overhang the field.

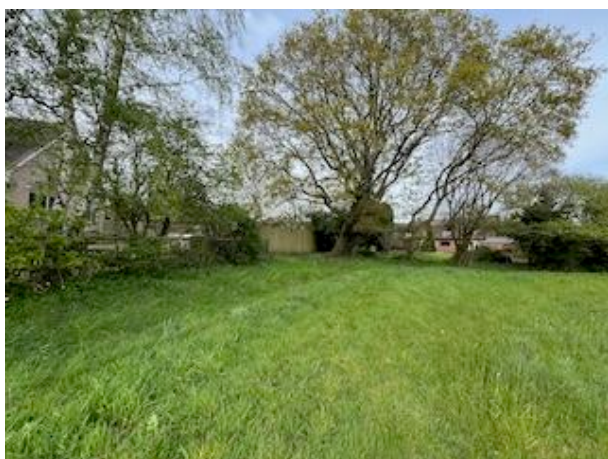
Photo: 4744

This photo shows the north west corner of the field. Belle Vue South is on the left and Badger's Holt in the centre distance. The boundary with Belle Vue South is a post and rail fence with some trees. Between Belle Vue South and Badger's Holt, the boundary is formed by a solid wooden fence. There is a medium size tree in the field close to the boundary. The ditch at this point is merely a shallow line in the grass only just visible in the photo. The ditch at this point is merely a shallow line in the grass.

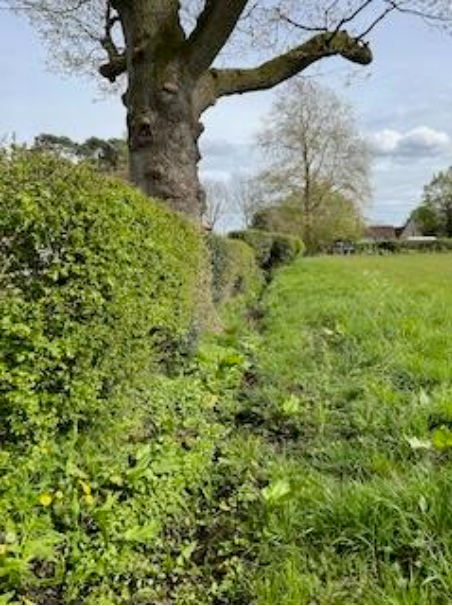
Photo: 4748

This photo shows the northern boundary between Corner Lea and the field. There is a mature oak in the boundary hedge with branches which overhang the field. This tree appears to have been the subject of **recent tree surgery**

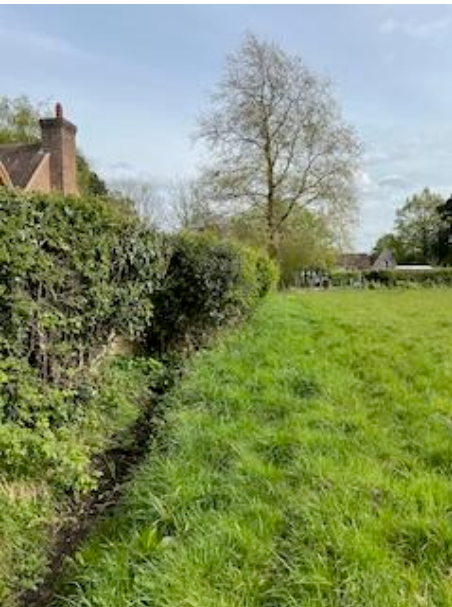
Photo: 4749

This photo shows the boundary between the field and Glebe Cottage which is at the eastern end of the northern boundary. The ditch along the boundary with Glebe Cottage appears to have been culverted at some time and the hedge planted over it. Assuming that the ditch is within the field, the hedge (or at least part of it) also must be within the field.

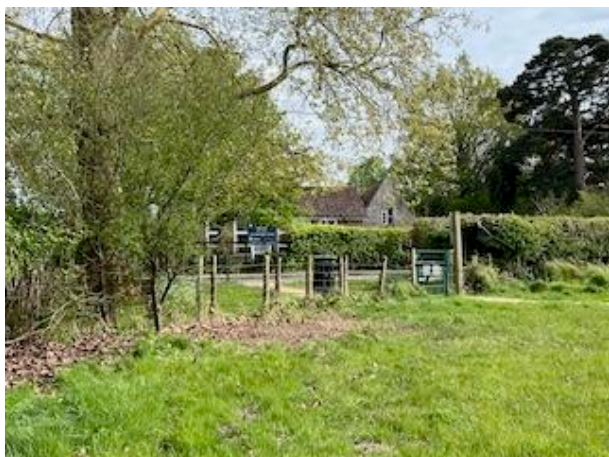
Photo: 4750

This photo shows the triangle of land known as “Brownies Corner” owned by the Parish Council where the northern boundary meets the eastern boundary. Separating the field from this triangle, there is fence formed by wooden posts and wire sheep netting (not in good condition) without any hedge. There is a gate into the field. There is a fine sycamore tree on the triangle. There are 2 seats and a rubbish bin.

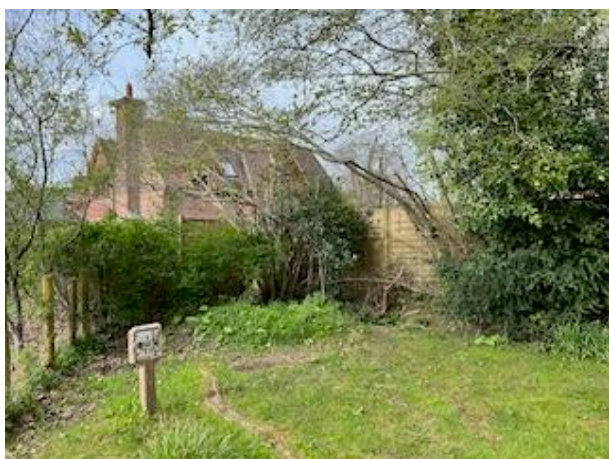
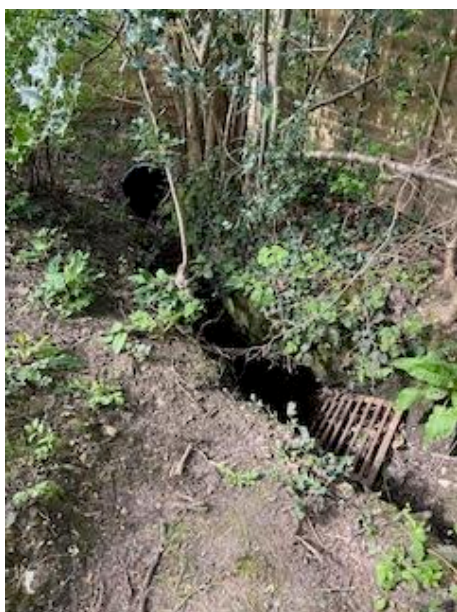
Photo: 4752

This photo shows the triangle known as Brownies Corner. On the boundary between the triangle and the garden of Glebe Cottage there is a solid wooden panel fence with miscellaneous shrubs such as holly and hazel in poor condition. Parallel to the fence, there is a short length of open ditch (see photo 4751). The water in the ditch flows in a westerly direction and disappears into a culvert under the hedge on the boundary with Glebe Cottage (see also photo 4749). The purpose of the ditch appears to be to carry surface water run-off from the roads and other areas.

See the text to photo 4752

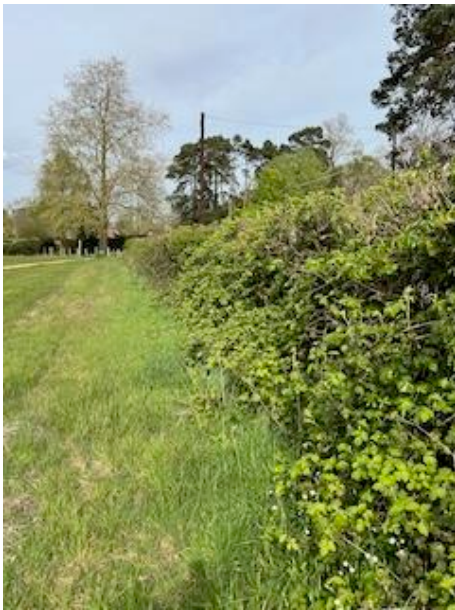
Photo: 4753

This photo shows the eastern boundary of the field looking towards Brownies Corner. The hedge runs parallel with Church Road. The hedge comprises a mixture of species and the size of many of the trunks indicates that it is of considerable age. It appears to have been regularly maintained with both sides and the top cut in the winter of 2023/24. There are several gaps which in due course may need supplementary planting (see photos 4756, 4763 and 4759 below).

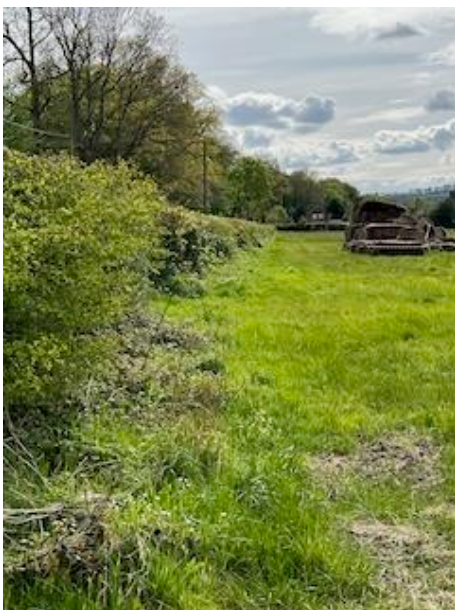
Photo: 4754

The section of the eastern boundary looking south from the gate. There is a semi-mature sycamore tree in the hedge line close to a wooden telegraph pole.

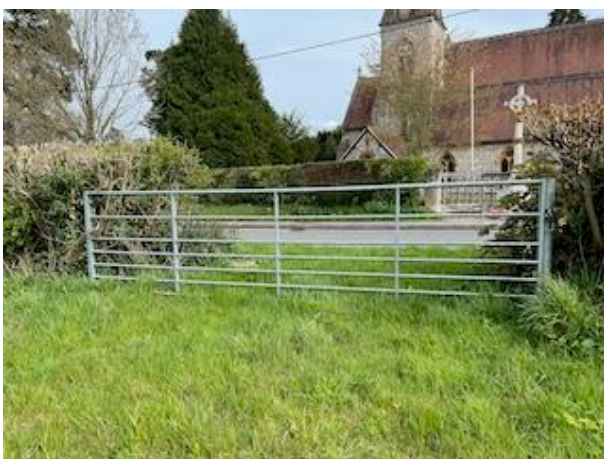
Photo: 4755

A 4m metal gate provides good access for agricultural vehicles from Church Road

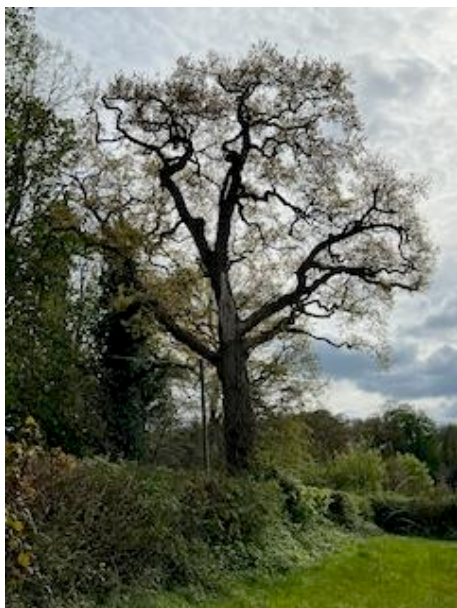
Photo: 4762

This photo shows the southern section of the eastern boundary looking south. There is a large oak tree within the hedge. It appears that a large branch has fallen off in the recent past leaving very obvious damage. Branches of this tree overhang the public highway Church Road.

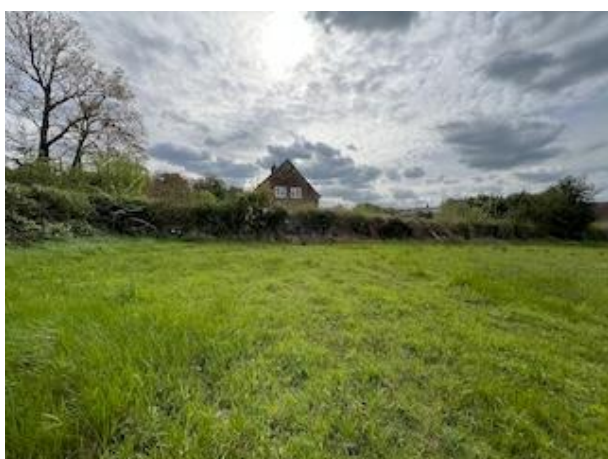
Photo: 4763

This photo shows part of the southern boundary adjacent to Copnor.

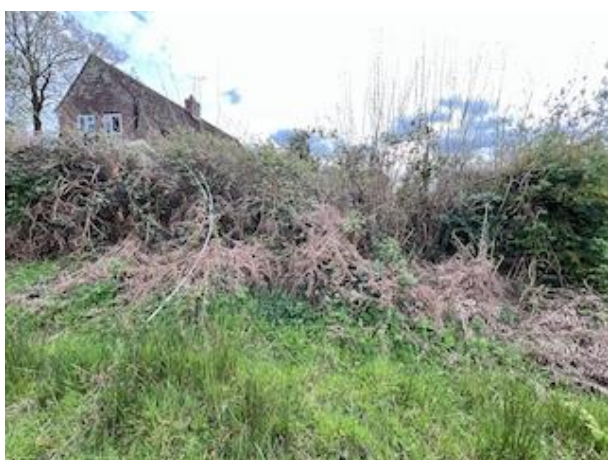
Photo: 4764

This photo shows part of the southern boundary adjacent to Copnor.

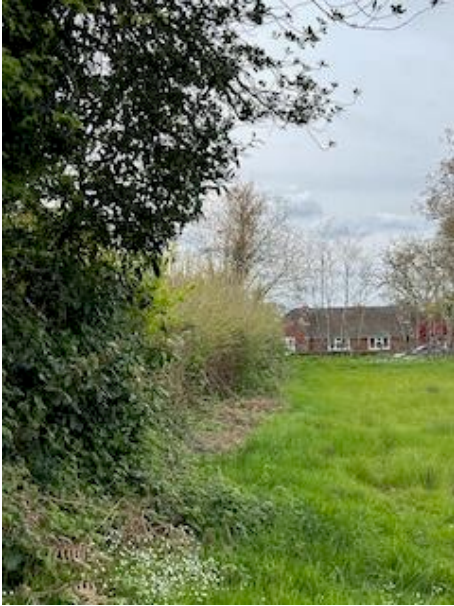
Photo: 4765

This photo shows the southern boundary looking towards the house next to the doctor's surgery.

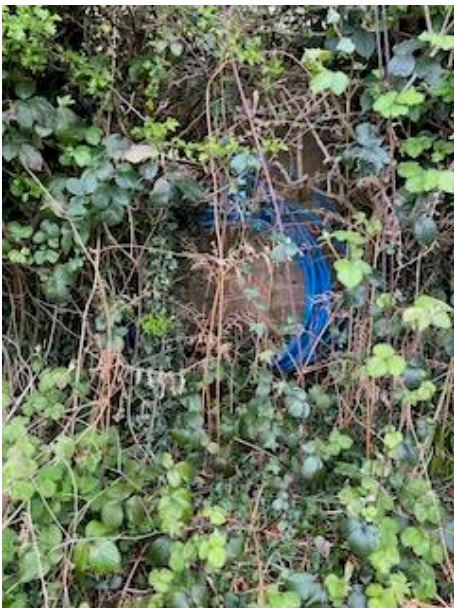
Photo: 4766

Large coil of blue water supply pipe embedded in undergrowth on southern boundary. Without cutting back the vegetation, it is not clear whether it is connected and serves a function or has just been discarded.
