ASBESTOS CONTRACTING LIMITED

Asbestos Re-Inspection for West Moors Memorial Hall

West Moors Memorial Hall
231 Station Road
West Moors
Dorset
BH22 0HZ

Project Number: AS10008 & AS10120

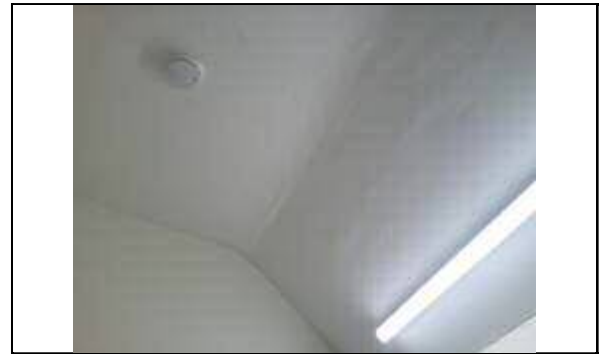
Location ID:	18394
Location Ref:	Visual ID to sample 2
Product:	Cement board
Area:	03
Floor:	Ground floor
Room:	Lobby
Surveyor Name:	[REDACTED]
Drawing Ref:	03
Asbestos ?	Yes
Date:	05 January 2023

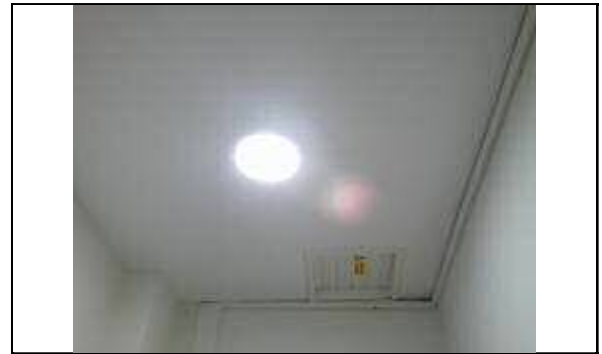
Location ID:	18400
Location Ref:	Visual ID to sample 2
Product:	Cement board
Area:	04
Floor:	Ground floor
Room:	Lobby
Surveyor Name:	[REDACTED]
Drawing Ref:	04
Asbestos ?	Yes
Date:	05 January 2023

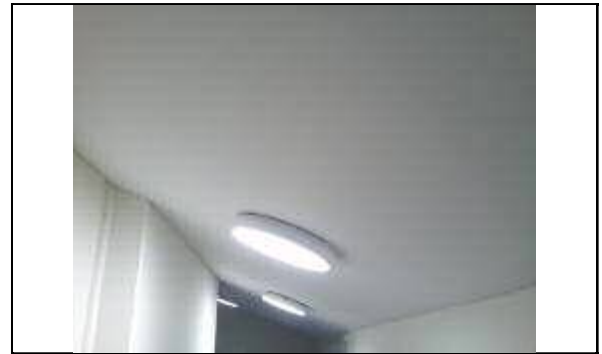
Location ID:	18402
Location Ref:	Sample 2
Product:	Cement board
Area:	05
Floor:	Ground floor
Room:	Circulation
Surveyor Name:	██████████
Drawing Ref:	05
Asbestos ?	Yes
Date:	05 January 2023

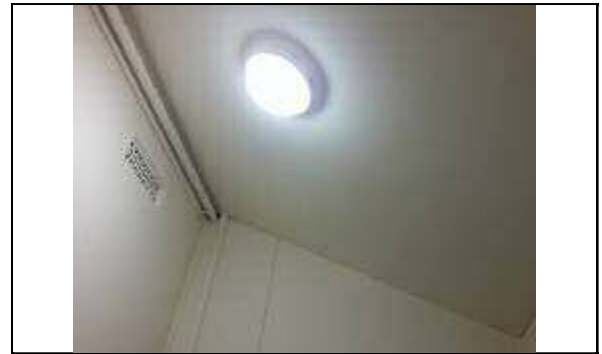
Location ID:	18408
Location Ref:	Visual ID to sample 2
Product:	Cement board
Area:	06
Floor:	Ground floor
Room:	Womens Toilet
Surveyor Name:	[REDACTED]
Drawing Ref:	06
Asbestos ?	Yes
Date:	05 January 2023

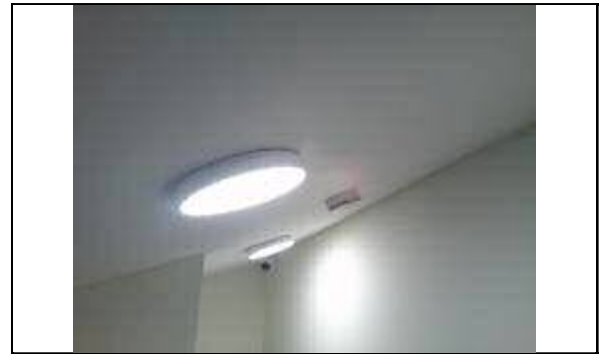
Location ID:	18409
Location Ref:	Visual ID to sample 2
Product:	Cement board
Area:	07
Floor:	Ground floor
Room:	Circulation
Surveyor Name:	[REDACTED]
Drawing Ref:	07
Asbestos ?	Yes
Date:	05 January 2023

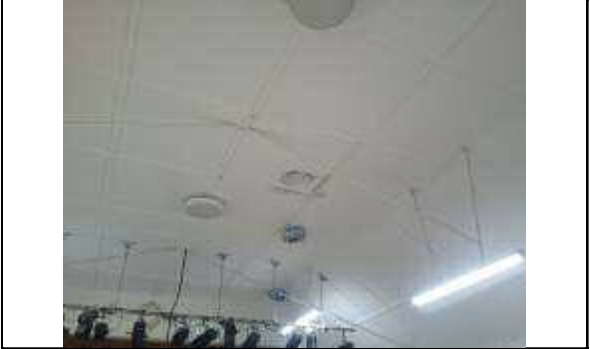
Location ID:	18411

<p>Priority Comments:</p>
Location Ref:	Visual ID to sample 2		
Product:	Cement board		
Area:	11		
Floor:	Ground floor		
Room:	Hall		
Surveyor Name:	[REDACTED]		
Drawing Ref:	11		
Asbestos ?	Yes		
Date:	05 January 2023

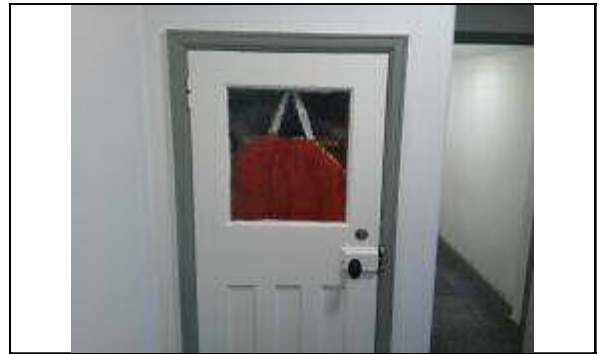
Location ID:	18412
Location Ref:	Visual ID to sample 2
Product:	Cement board
Area:	12
Floor:	Ground floor
Room:	Mens Toilet
Surveyor Name:	[REDACTED]
Drawing Ref:	12
Asbestos ?	Yes
Date:	05 January 2023

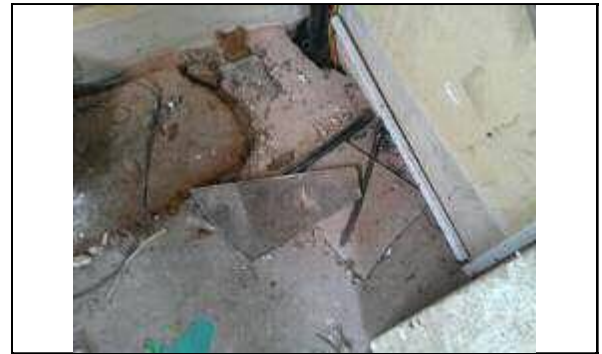
Location ID:	18414
Location Ref:	Visual ID
Product:	Cement board debris
Area:	18
Floor:	Roof
Room:	Projector room
Surveyor Name:	██████████
Drawing Ref:	18
Asbestos ?	Yes
Date:	05 January 2023

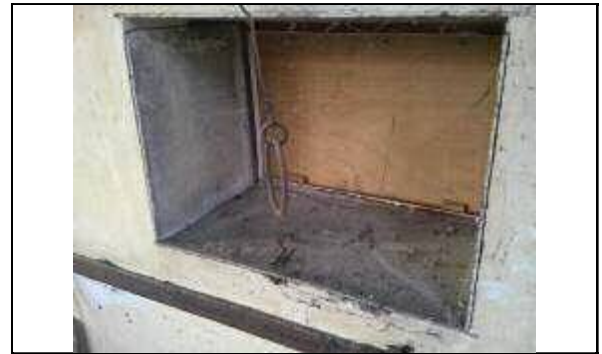
Location ID:	18413
Location Ref:	Visual ID
Product:	Cement board
Area:	18
Floor:	Roof
Room:	Projector room
Surveyor Name:	██████████
Drawing Ref:	18
Asbestos ?	Yes
Date:	05 January 2023

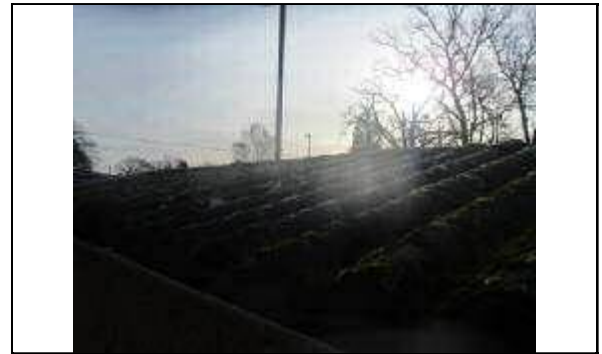
Location ID:	71884
Location Ref:	Sample 5 (AS10120)
Product:	Cement Roof Sheets
Area:	19
Floor:	External
Room:	External
Surveyor Name:	[REDACTED]
Drawing Ref:	19
Asbestos ?	Yes
Date:	03 February 2023

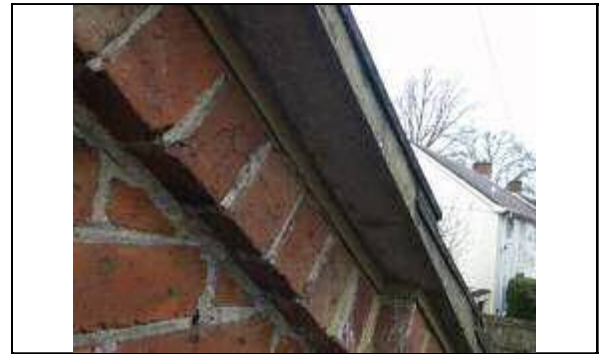
Location ID:	18415
Location Ref:	Visual ID
Product:	Undercloaking
Area:	19
Floor:	External
Room:	General externals
Surveyor Name:	██████████
Drawing Ref:	19
Asbestos ?	Yes
Date:	05 January 2023

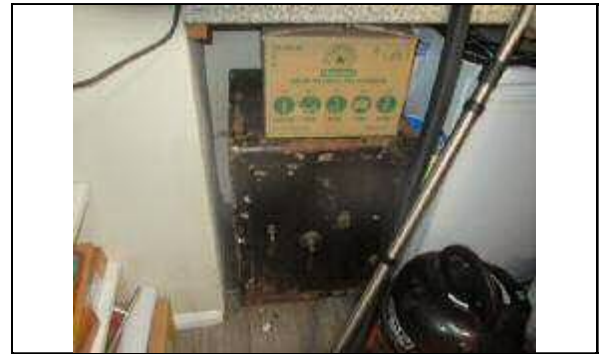
Location ID:	71871
Location Ref:	Visual ID
Product:	Safe
Area:	22
Floor:	Ground floor
Room:	Bar
Surveyor Name:	[REDACTED]
Drawing Ref:	22
Asbestos ?	Yes
Date:	03 February 2023

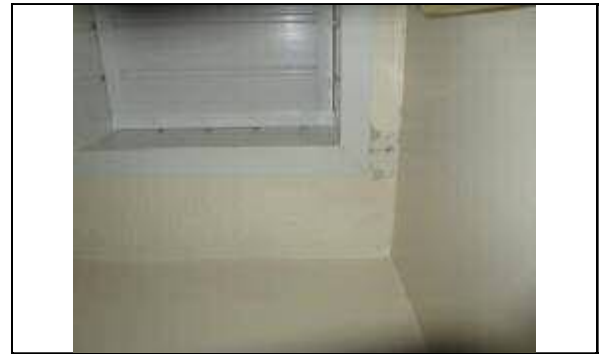
Location ID:	71875
Location Ref:	Sample 2 (AS10120)
Product:	Textured coating
Area:	24
Floor:	Ground floor
Room:	Mens Toilet
Surveyor Name:	[REDACTED]
Drawing Ref:	24
Asbestos ?	Yes
Date:	03 February 2023
